Morphology of FZG-A Test Gears

Robert Errichello and Liam Coen

This study explores the failure mode morphology of FZG-A test gears. It aims to examine the morphologies of scuffing, scoring, scratches, and polishing using high-magnification light optical microscopy (LOM) and scanning electron microscopy (SEM) images.

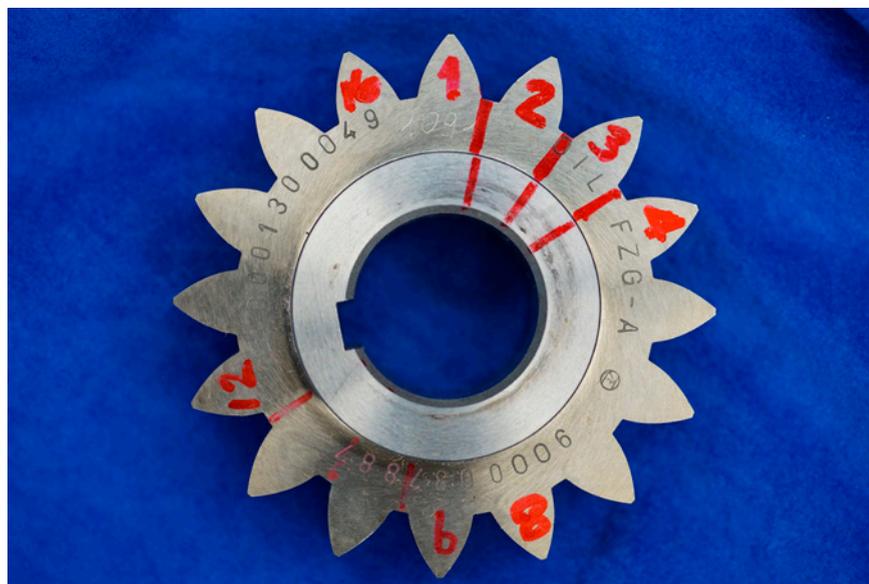
Figure 1—FZG-A Pinion.

Figure 1 illustrates an FZG-A spur pinion with 16 teeth that meshes with a spur gear featuring 24 teeth. Detailed geometric information about both the pinion and the gear can be found in Annex A. For the LOM and SEM investigation, teeth 2 and 3 were removed by cutting along the red radial lines indicated in the figure.

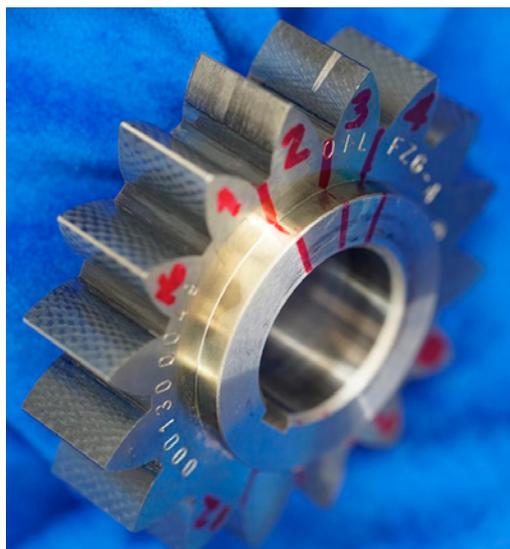
Figure 2 illustrates scuffing on teeth 2 and 3. Tooth 2 exhibits scuffing nearly across the entire face width, while tooth 3 shows a narrow band of scuffing. The other teeth, which do not exhibit scuffing, display the unique surface texture produced by the MAAG 15-degree crisscross grinding method.

Figure 2—Typical scuffing on teeth 2 and 3.

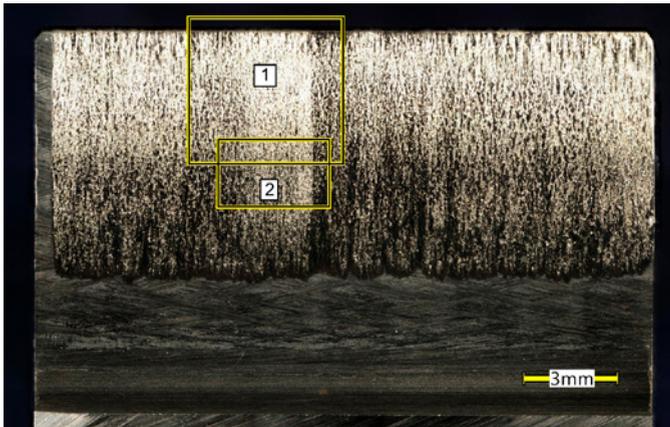
Figure 3—LOM image of tooth 2 shown in Figure 2.

Figure 3 shows the scuffing observed on tooth 2, which is also illustrated in Figure 2. The scuffing measures 19.5 mm in width, almost covering the total face width of 20 mm. To the unaided eye, or when viewed under LOM, the scuffed area appears as a dull grey surface.

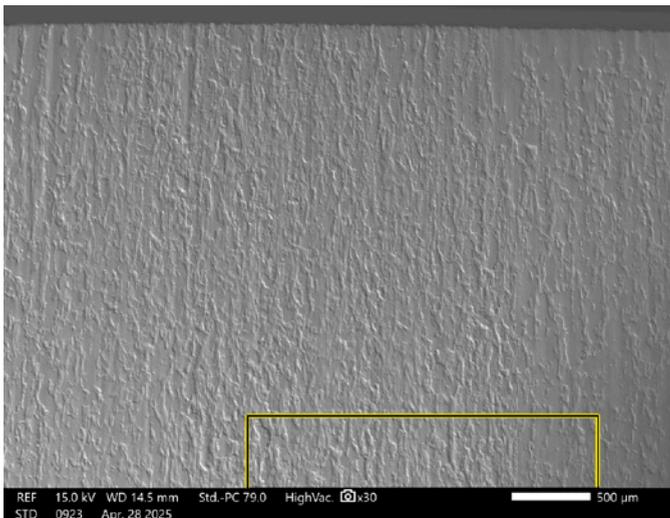
Figure 4—SEM image of Box 1 shown in Figure 3.

Figure 4 shows that scuffing results in a rough surface, which covers the original grinding marks. The top of Box 2 is shown at the bottom of Figure 4 and in Figure 5.

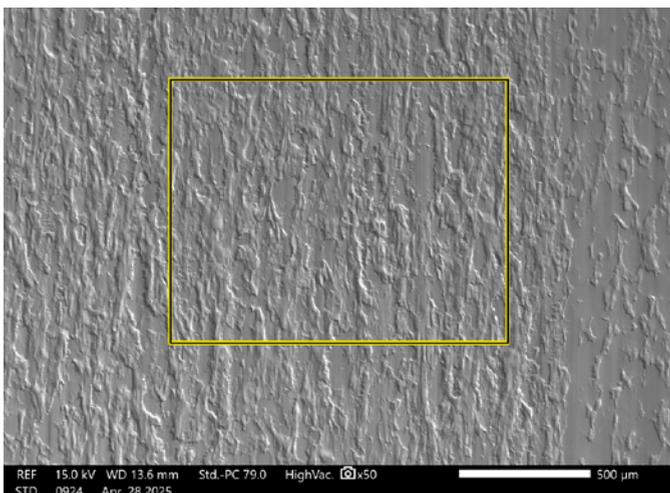
Figure 5—SEM image of Box 2 shown in Figure 3.

Figures 5 through 8 are SEM images of scuffing shown at progressively increasing magnification from 50× to 750× magnification.

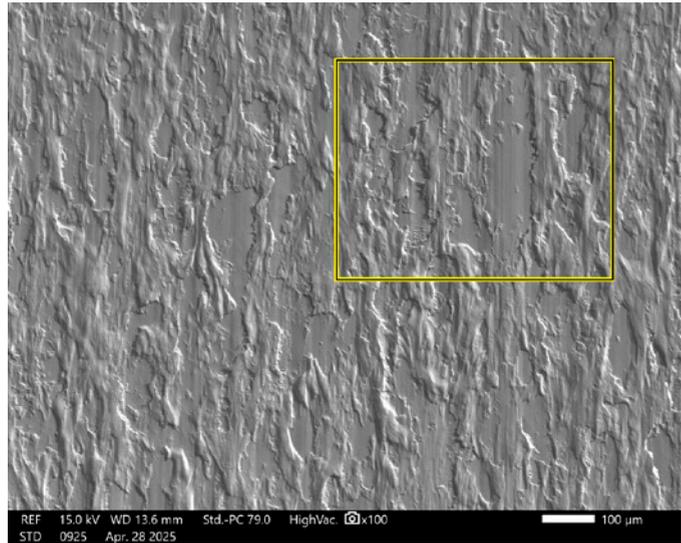
Figure 6—SEM image of Box shown in Figure 5.

Figure 6 illustrates the area of the Box depicted in Figure 5. The area within the Box in Figure 6 is represented in the subsequent Figure 7.

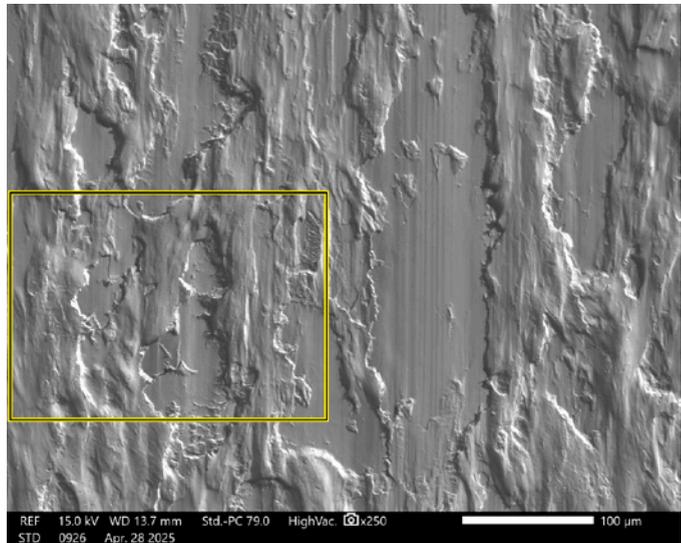
Figure 7—SEM image of Box shown in Figure 6.

Figure 7 shows the area of the Box shown in Figure 6. The area within the Box in Figure 7 is represented in the subsequent Figure 8.

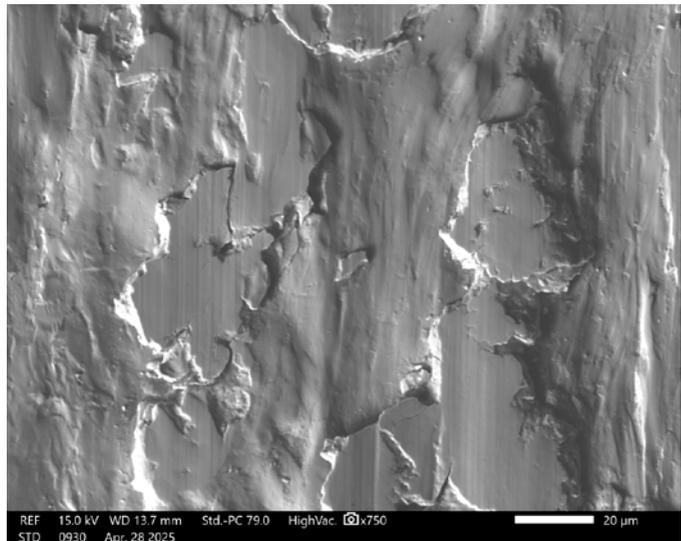
Figure 8 shows the area of the Box shown in Figure 7. It illustrates the morphology of the transferred particles, which appear as discrete islands of raised patches. These patches were transferred from the meshing flanks of the wheel and welded onto the pinion flanks. The top surfaces of these patches have become smooth due to abrasive wear, as shown by the abrasion lines that run in the vertical sliding direction. The tractional shear stresses associated with this abrasion have led to the formation of several cracks within the transferred patches. If the shear stress on the top surface of a transferred patch exceeds the shear strength of the weld interface on its lower surface, the patch may dislodge and become a freed debris particle.

Figure 8—SEM image of Box shown in Figure 6.

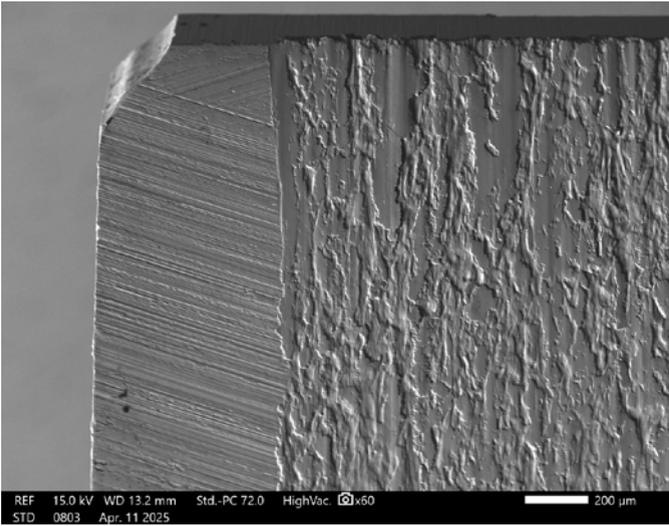
Figure 9 illustrates the left corner of tooth 2, where scuffing does not extend to the left end of the face width. The original grind marks are visible in the area that remains free of scuffing. Additionally, plastic deformation of the transferred material has flowed over the tip of the tooth.

Figure 9—SEM image of left corner of tooth shown in Figure 3.

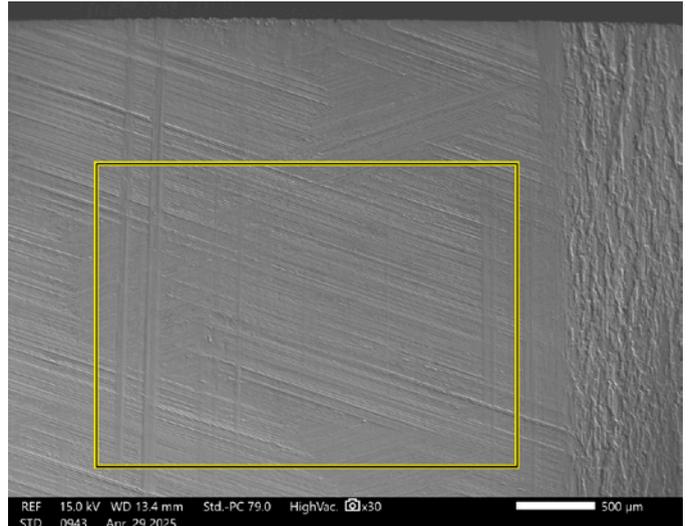
Figure 12—SEM image of Box 1 shown in Figure 11.

Figure 12 shows the area of Box 1 that includes the tip of the tooth at the top of the image and the edge of the scuffing at the right side of the image. The Box in Figure 12 corresponds to Box 2 in Figure 11. The area within the Box in Figure 12 is represented in the subsequent Figure 13.

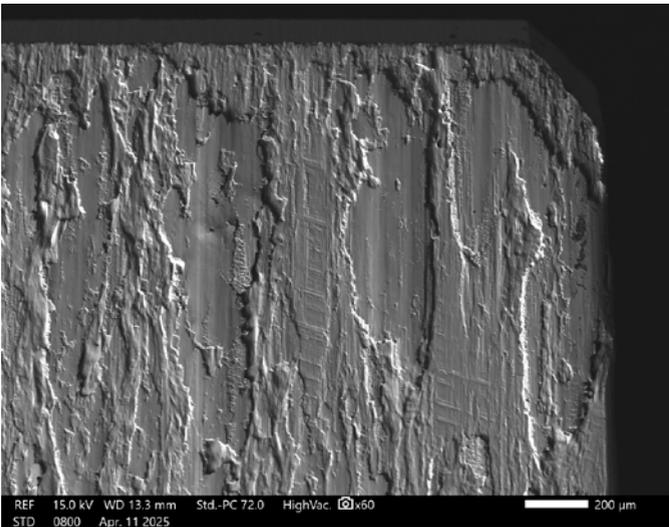
Figure 10 illustrates that the transferred patches are elevated above the original ground surface of the tooth flank. As a result, the load is carried exclusively by these transferred patches, while the areas of the original ground flank are unloaded. This situation leads to self-aggravating scuffing.

Figure 10—SEM image of right corner of tooth shown in Figure 3.

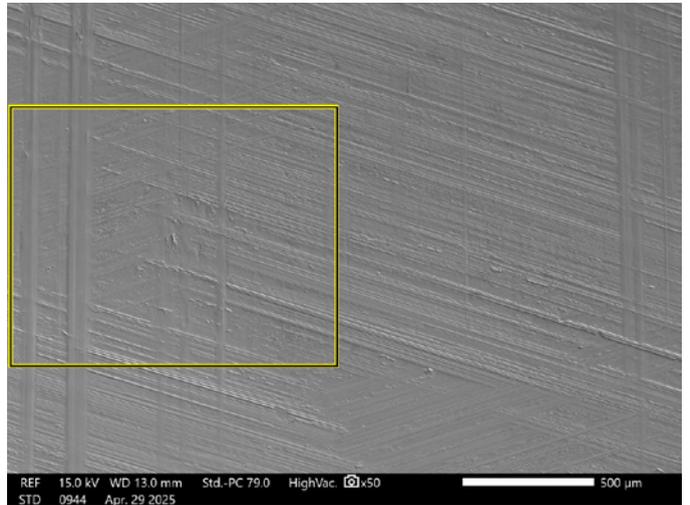
Figure 13—SEM image of Box 2 shown in Figure 12.

Figure 13 shows the area of Box 2 at a 50× magnification. Prominent vertical lines, which indicate abrasive wear, are clearly visible. In the background, the original crisscross grinding marks can still be seen, offering insight into the depth of the abrasive wear. The area within the Box in Figure 13 is represented in the subsequent Figure 14.

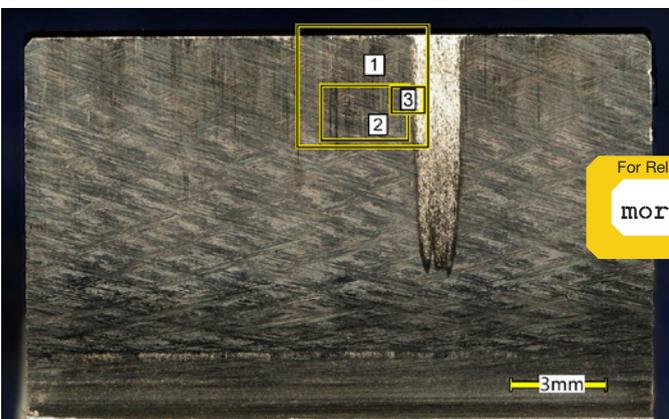
Figure 11 illustrates a 1.4 mm-wide band of scuffing that starts at the lower part of the tooth and extends up to its tip.

Figure 11—LOM image of tooth 3 shown in Figure 2.

Additionally, there is a narrow band of scuffing along the edge of the tooth tip and a narrow band of scuffing near the root of the tooth, at the start of the active profile (SAP). FZG-A gears lack tip or root relief on their profiles, which leads

to high loads at both the SAP and the end of the active profile (EAP) at the tips of the pinion teeth. This condition increases the likelihood of scuffing in these areas.

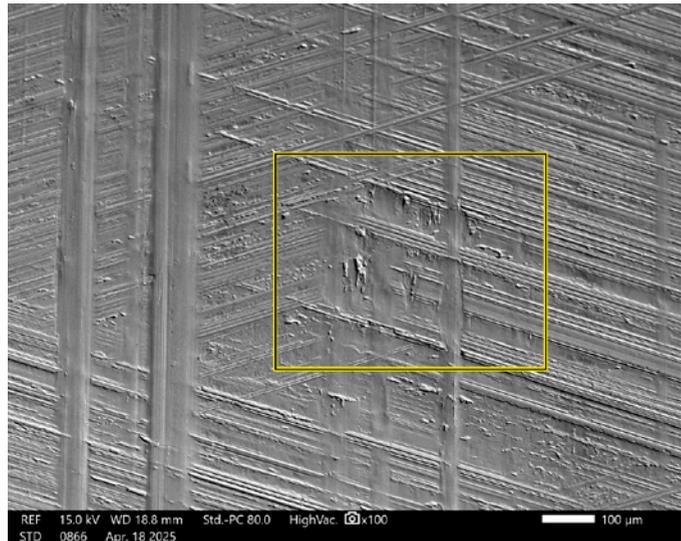
Figure 14 provides an enlarged view of the Box depicted in Figure 13. The vertical lines of abrasive wear have erased the original grinding marks. Additionally, the Box in Figure 14 highlights an area of localized scuffing and plastic deformation. The area within the Box in Figure 14 is represented in the subsequent Figure 15.

Figure 14—SEM image of Box 2 shown in Figure 13.

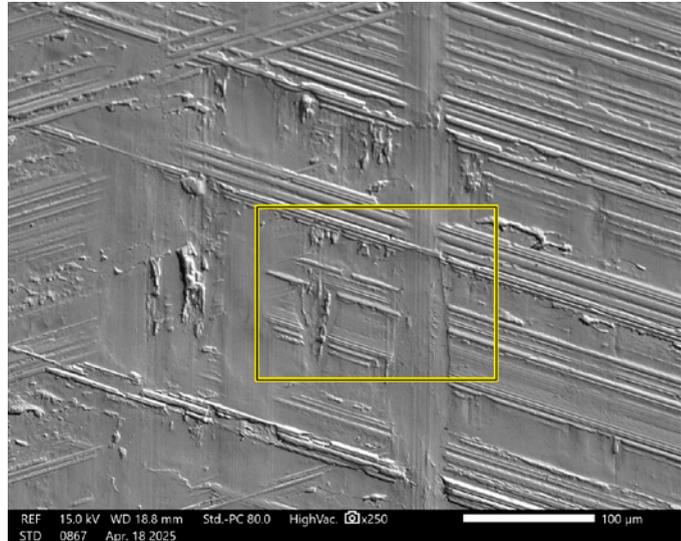
Figure 15 presents an enlarged view of the Box shown in Figure 14. It illustrates scuffing and plastic deformation of the surface material, which has removed the original grinding marks in certain areas. Additionally, the Box in Figure 15 highlights an area of localized plastic deformation. The area within the Box in Figure 15 is represented in the subsequent Figure 16.

Figure 15—SEM image of Box 2 shown in Figure 14.

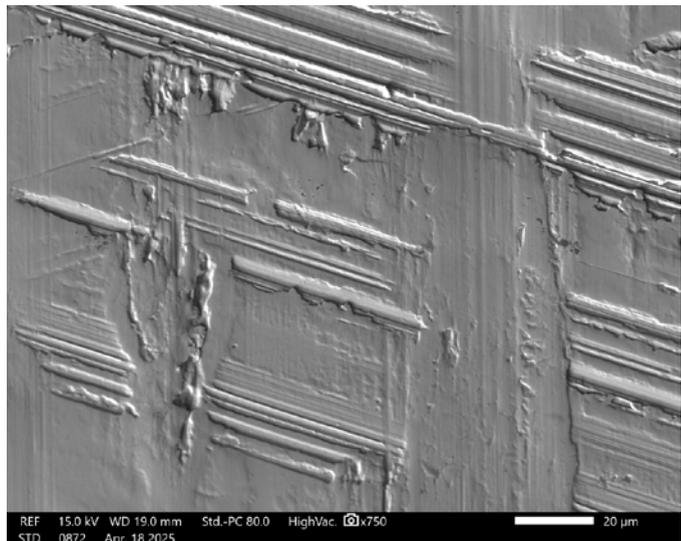
Figure 16 provides a closer view of the Box depicted in Figure 15. Plastic deformation has caused the surface material to flow upward into the original grind marks, aligning with the upward direction of the sliding motion on the pinion tooth.

Figure 16—SEM image of Box 2 shown in Figure 15.

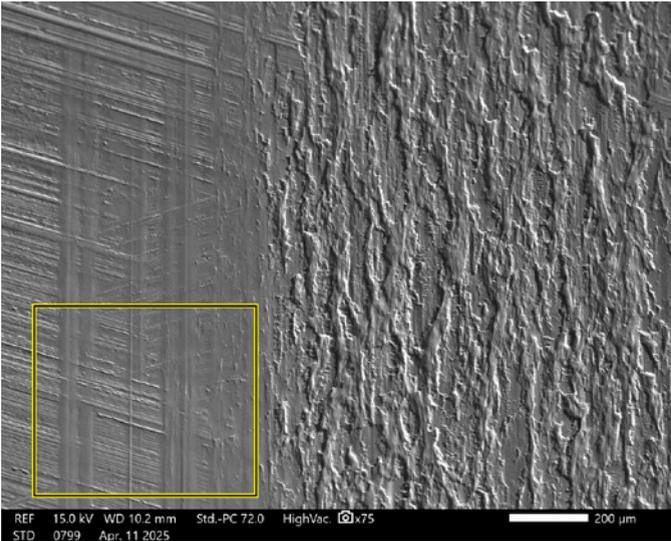
Figure 17 shows the area of Box 3 from Figure 11, emphasizing the scuffed region on the right side of the image and the signs of abrasive wear on the left. The Box in Figure 17 outlines an area that exhibits scoring, scratches, and polishing.

Figure 17—SEM image of Box 3 shown in Figure 11.

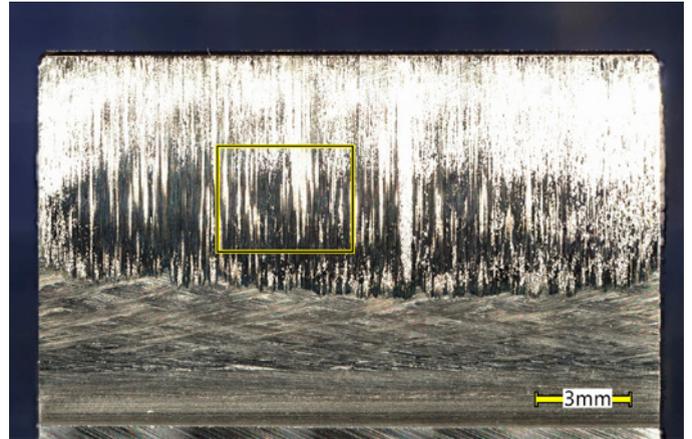
Figure 20—LOM image of tooth 8 shown in Figure 1.

Figure 20 shows that tooth 8 has scuffing and polishing. The Box shown in Figure 20 outlines an area of polishing. The area within the Box in Figure 20 is represented in the subsequent Figure 21.

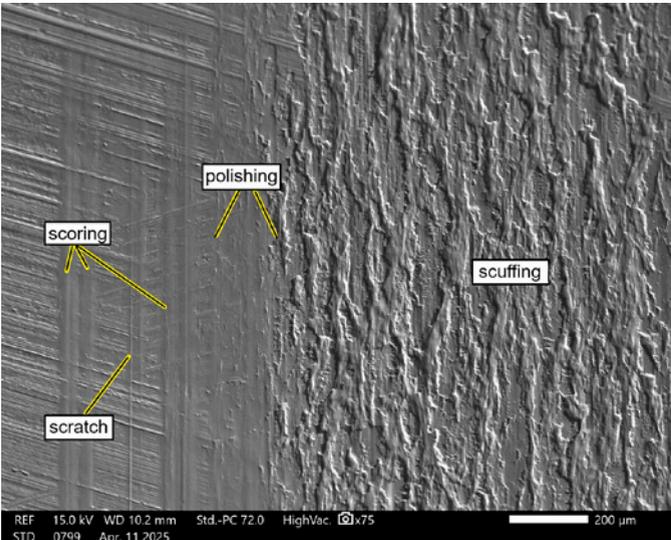
Figure 18 is identical to Figure 17, but it has been annotated to highlight the failure modes of scuffing, scoring, scratches, and polishing. It is evident that scoring and scratches share the same morphology; however, they differ in width.

Figure 18—SEM image with labeled features of interest from Figure 17.

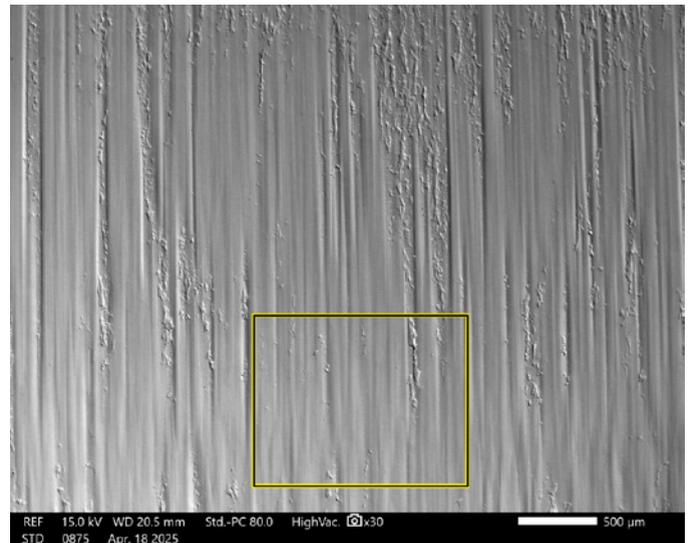
Figure 21—SEM image of Box shown in Figure 20.

Figure 21 shows the area of the Box depicted in Figure 20. It predominantly features polishing along with some lightly scuffed areas. The Box represented in Figure 21 is displayed at a higher magnification in Figure 22.

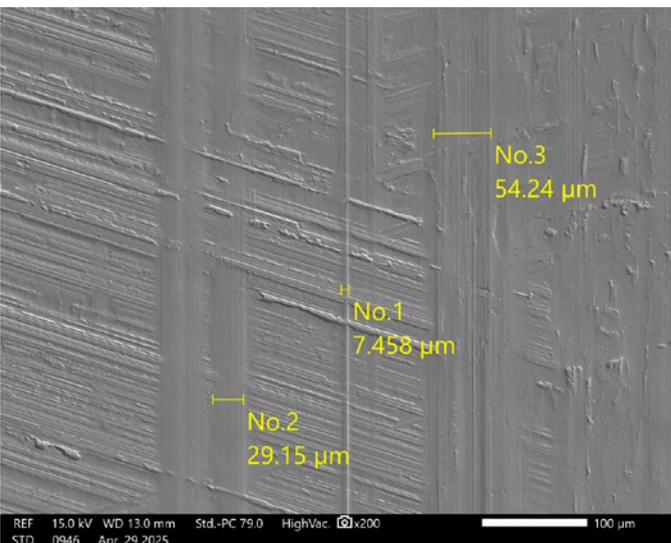
Figure 19 presents an enlarged view of the Box shown in Figure 17. Figure 19 shows that scoring and scratches exhibit similar abrasive wear patterns, characterized by smooth, clean furrows that align

Figure 19—SEM image of Box 3 shown in Figure 17.

with the direction of sliding. However, under intense oblique light, scratches become more noticeable due to specular reflection. Generally, scratches are typically less than 30 μm wide, while scoring is usually wider than 30 μm .

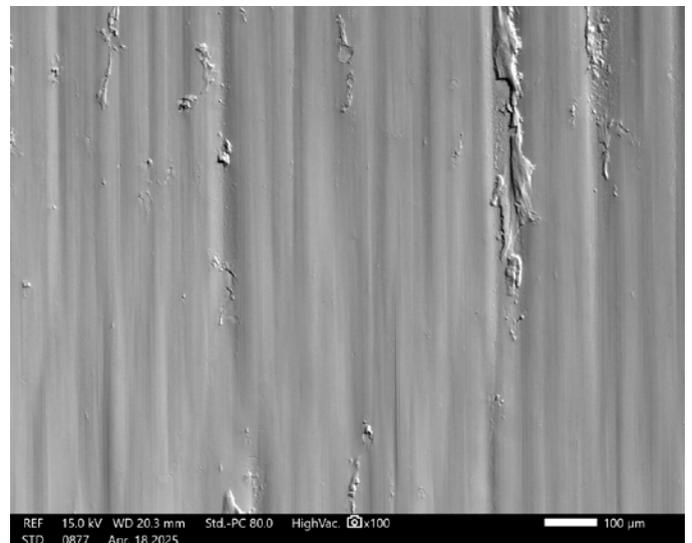
Figure 22—SEM image of Box shown in Figure 21.

Figure 22 shows the area of the Box referenced in Figure 21. Polishing wear has completely removed the original grinding marks, resulting in a smooth, mirror-like surface finish. If the scuffing is not too severe, and the operating conditions remain stable, polishing wear can give the appearance of healing the scuff marks. However, it is important to note that the polished surface shows undulations, with scuffing occurring at the peaks of these undulations. Therefore, while polishing can improve surface appearance, it can also be harmful if it removes a significant amount of surface material.
