SARJ

REPAIRS SHOW PROMISE FOR SPACE STATION SOLAR POWER

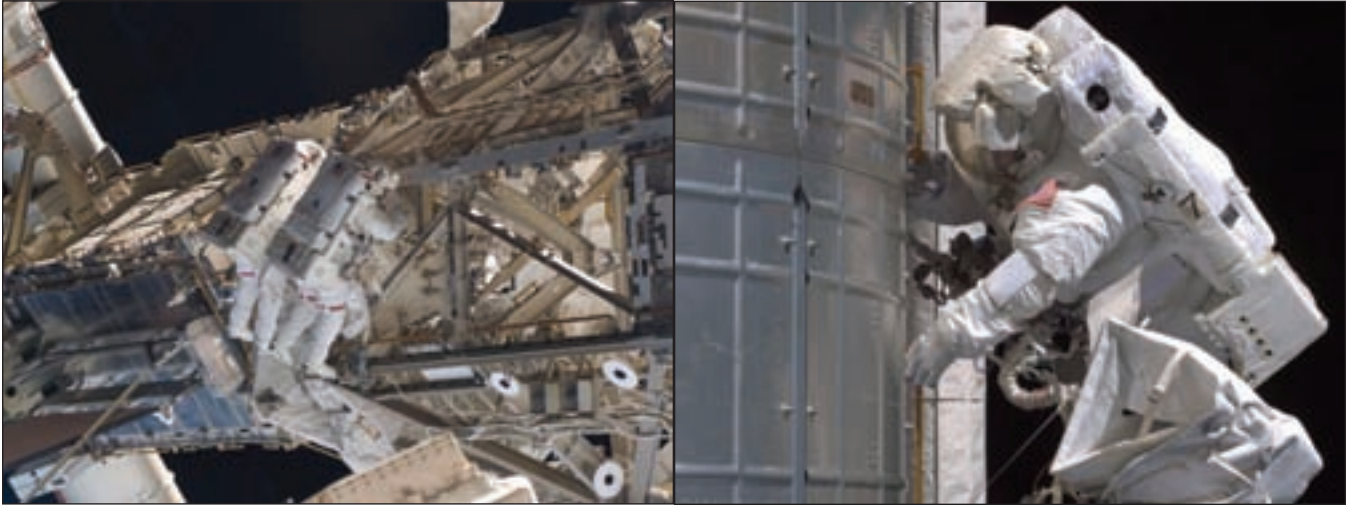
Several spacewalks were required to make repairs to the SARJ. Photo/NASA.

From the beginning, the areas of greatest concern for flight engineers on the ground were the build-up of grit-like particles on the raceway of the TBAs, vibration in the SARJ truss and a spike upward in the motor current powering the system. As reported previously, these problems resulted in the SARJ being in disabled mode since its installation.

canted surfaces are at a 45 degree angle, the other is a flat surface. The bearings themselves have lubricant internal to the bearings and that’s Braycote 601. But the lubricant that was utilized to lube the inner face between the trundle bearings roller and the race ring itself was gold—a solid lubricant. What we have determined in tests is that the lack of lubrication on that inner face causes excessive friction, which we have proven in a vacuum test that that excessive friction causes the bearings to tip on-edge, which increases our surface stress, and the surface stress was high enough to crack the nitride layer. That is what we have determined was the root cause.”

“We went out there with a scraping tool, some wipes and Braycote 602, and we cleaned away as much debris (grit) as we possibly could,” says Window. “We reapplied a one-eighth bead of lubricant all the way around on all three surfaces. We replaced the trundle bearings, and since then we have rotated (the SARJ) two complete revolutions. And what we have found is that the motor current that we had seen prior to lubrication has gone down tremendously. We had seen motor currents of .9 amps, and we’re down to an average of .17 amps. We’re
