Surface Damage Caused by Gear Profile Grinding and Its Effects on Flank Load Carrying Capacity

Prof. Dr.-Ing. Fritz Klocke and
Dr.-Ing. Heiko Schlattmeier

Management Summary

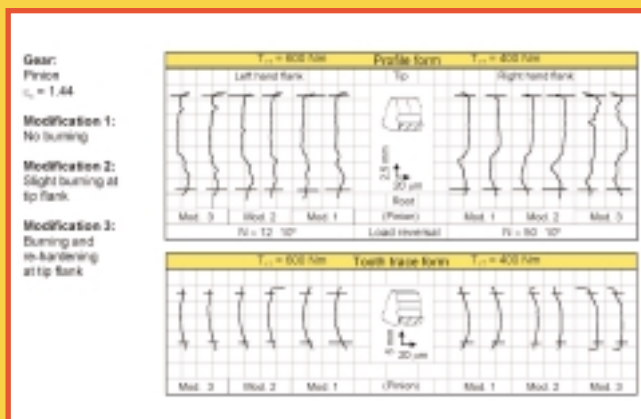
Figure 10—Test gear wheels after use, depending on different torques.

Measurements of the profile form and the tooth trace form of the used pinion on the teeth without pitting damages show locations in which the tooth flank is mostly impacted during the operation (Fig. 10).

Independent of the test variant and the chosen torque, there are visible deviations of approximately $10\text{ }\mu\text{m}$ in the lower area of the root flank. The deviating point is a plastic deformation of the material during the running or at fatigue phenomena of tooth flanks (wear). The pitting in this area in experiments with a torque of $T_{1T} = 600$ Nm can contribute to the high local flank pressure and the negative slippage (Ref. 17).

On the pinion with a new hardening area, profile form deviations occur independently of the load level at the tip flank, as it can be clearly seen on the right tooth flank after a number of load cycles of $N \approx 50 \cdot 10^6$ at a torque of $T_{1T} = 400$ Nm. The local generating load of the material in the area of the flank tip is lower because of the lower flank pressure and the positive slippage. The deviations therefore point at the fact, that the load carrying capacity of the material is strongly reduced in the fringe structure, which is damaged in the grinding process.

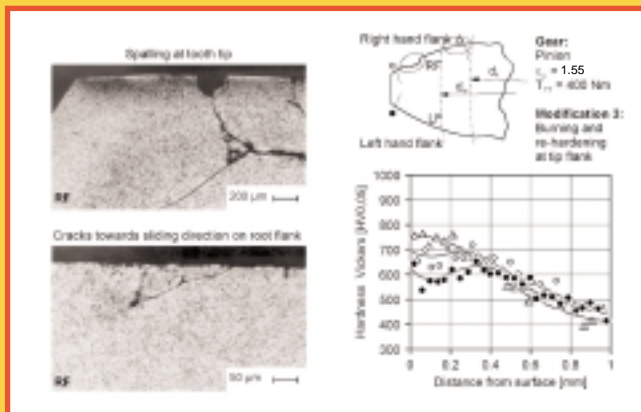
Figure 11—Structure and hardness measurements after use.

exactly by means of structure research (Fig. 11). The structure images show, by the means of a dark tempered zone and a thin new hardening area, the gear damage caused by the grinding process. By means of the material structure, it becomes obvious that the structural damage is strongly shaped in the area of the tip flank. Compared to the damage on the root flank, the tip flank has some deep cracks, which are processed normally to the flank surface and deeply into the surface. In a depth of approximately 6 mm, the cracks process parallel to the flank surface. The course of the cracks indicates that, during the further use of the test pinion, a massive damage in the form of a large surface of material break-outs of the tooth flank, or a break of the tooth in the tip area, could have occurred.

This realized damage could have been caused by the high measured tensile stresses in the structural damaged zone by grinding burns, which leads to an exceeding of the material stability (Refs. 7, 17).

In the area of the structural damage, the hardness on the tooth flank surface is reduced for at least 100 HV0.05, beginning from 750 HV0.05, measured on the undamaged structure in the area of the flank root. Since the stability of metallic materials depends on the material hardness (Ref. 21), the strong decrease of the hardness in the area of grinding burns indicates a reduced load carrying capacity of the surface.

Contrary to this, the area underneath the pitch circle shows only a low cleft formation in the fringe area. The cracks are running contrary to the sliding direction and are typical for gears under generating load (Ref. 17).

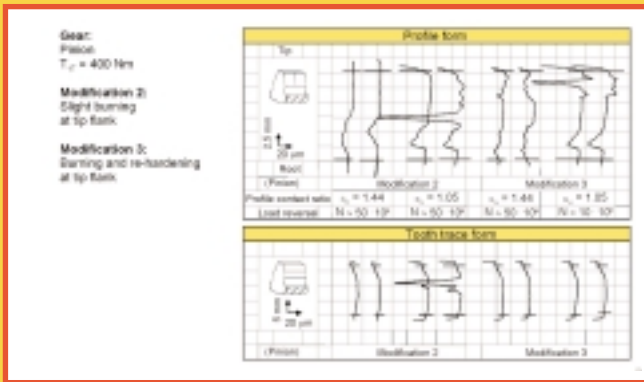
Figure 13—Test gear wheel after use, depending on profile contact ratio.

The measurements of the tooth profile and lead show more wear on the tip flank above the pitch circle especially for the significantly damaged pinion, variant 3 (Fig. 13).

The large differences from the profile form in the tip area indicate large breakouts. The cracks must be far below the tooth surface because they do not directly show on the flank surface, as the profile trace of variant 3 shows. The pinion with the slight grinding burn (variant 2) has significantly smaller deviations of the profile form in the tooth tip area. Increasing deviations in the area of the lead trace (pinion diameter) cannot be concluded except for the deviations caused by pittings.

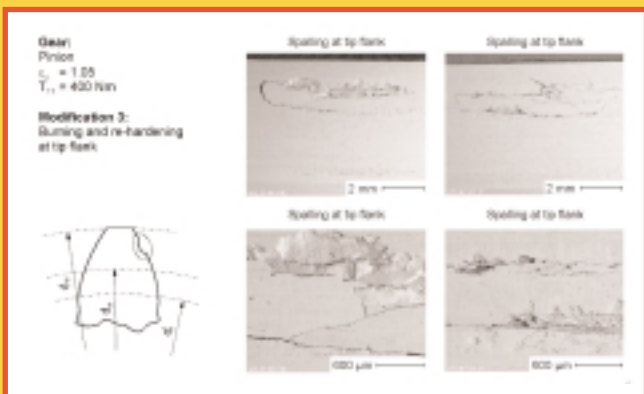
Figure 14—Damage on the tooth flank after use.

Figure 14 shows the damages on the tooth flanks of the pinion with a strong grinding burn. The large surface with material breakouts in the tip area and the overhanging material on the tooth flank are clearly visible. In Figure 14, a more detailed picture of a crack in the lead direction is shown.

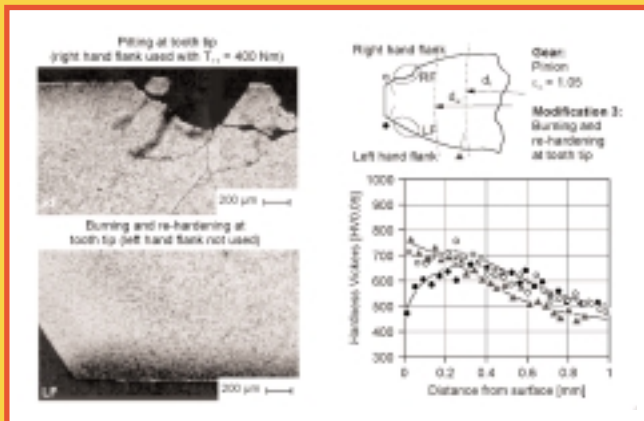
Figure 15—Structure and hardness measurement after use.

The material structure is shown in Figure 15. The intense structural damage of the martensite surface layer and the re-hardened zone in the tip area is clearly visible. In the gear with a contact ratio of $\epsilon_{\alpha} = 1.44$, the cracks in the pitting area were orientated opposite of the sliding direction. In contrast, the cracks in this case are significantly longer and run deep into the basic structure. The large surface areas with material breakouts indicate a change of the surface layer properties due to grinding burns. In this case, the measurement of residual stresses could help in order to find the cause of damage.
