Gear Corrosion During the Manufacturing Process

Omer El-Saeed, Gary Sroka and Gregory Blake

Management Summary

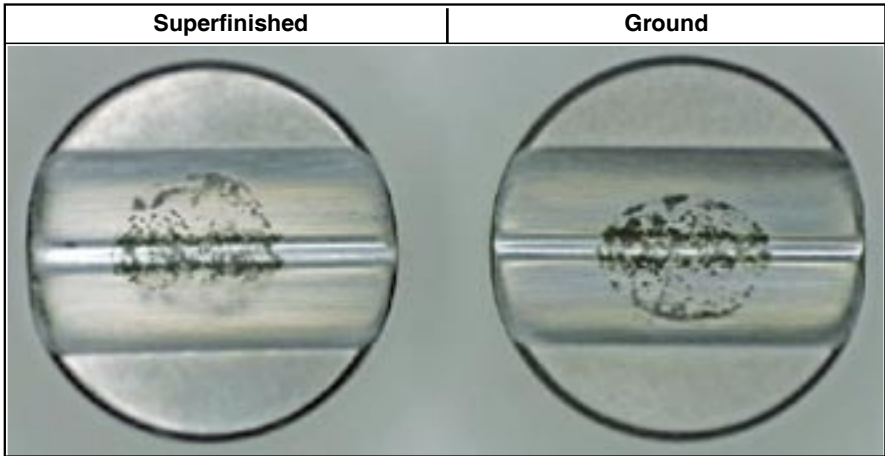
#0000 steel wool, followed by ultrasonic cleaning in a mildly caustic solution. Pitting corrosion, crevice corrosion and IGA were observed on both the superfinished surface and ground surface (Figs. 7–8).

Figure 7—View 3: Superfinished (l) and ground (r) after mechanical cleaning, showing residual corrosion.

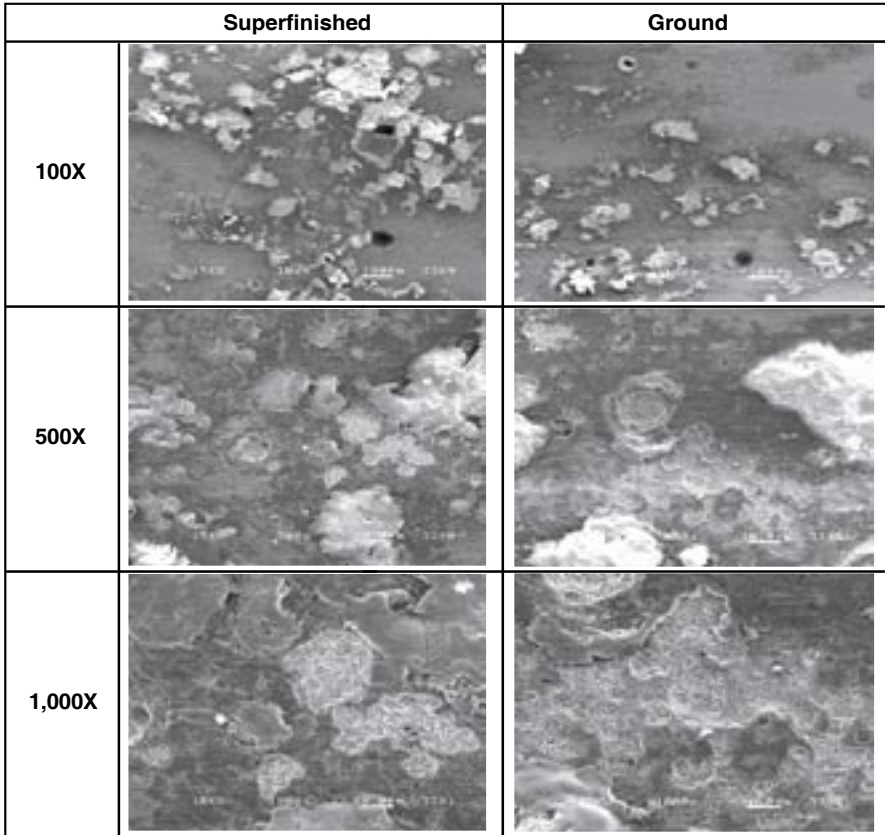
Figure 8—SEM images of test specimens after mechanical cleaning. Superfinished (l) and ground (r). Deep pits are visible in the 100X images. The white deposits cover shallower pits. IGA cracks are visible in the 1000X images.

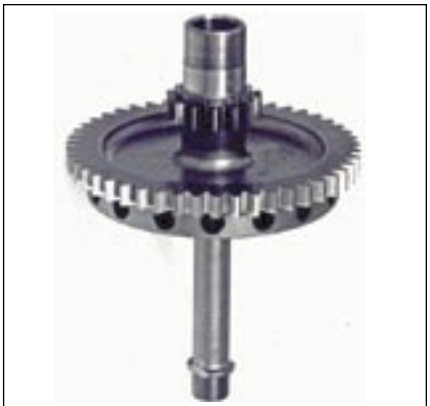
In 2000, Rolls-Royce Corp. sent used/scrap carburized AISI 9310 gasifier train gearshafts to REM Chemicals, Inc. for edge radiusing (Fig. 9).

Figure 9—As-received used/scrap carburized AISI 9310 gasifier train gearshaft.

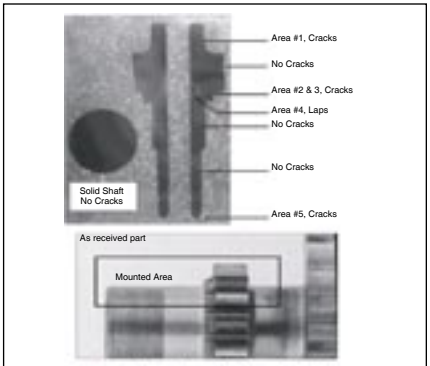
Figure 11—Locations of IGA and contact damage on gearshaft sections (top) taken from the gearshaft (bottom).

Superfinishing occurs in a mildly acidic medium. Consequently, the superfinished gearshafts were rigorously inspected for metallurgical damage upon return to Rolls-Royce. Surprisingly, intergranular attack (IGA) and surface microcracks were detected, and these were initially attributed to the superfinishing process. REM conducted their own inspection of a non-superfinished, scrap/used gearshaft at a metallurgical laboratory (Anderson & Associates, Houston, TX). The gearshaft was sectioned, polished, and examined. IGA as well as other surface damage were found proving that the damage was produced during the manufacturing process prior to superfinishing. Figure 11 shows the sections and the target inspection areas.

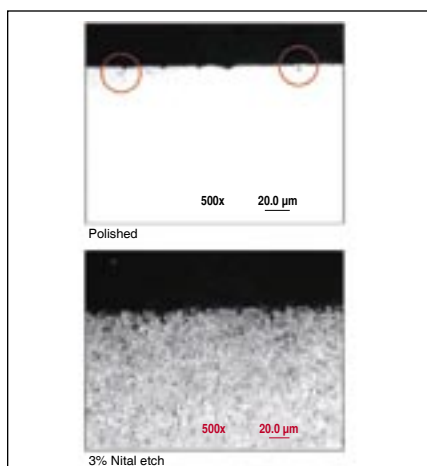
Figure 12—Photomicrographs of Area 1 at 500X magnification. Circles show several IGA cracks.

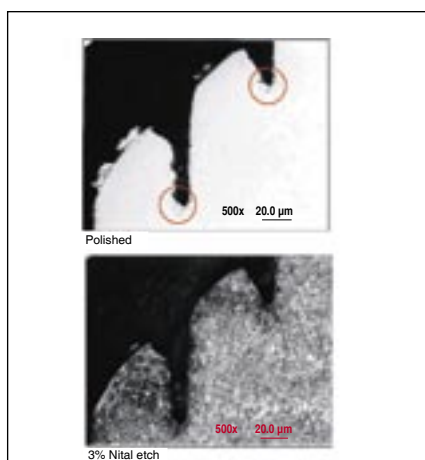
Figure 14—Photomicrograph of Area 3 at 500X magnification. Circles show visible IGA cracks in the valleys of the machining lines.

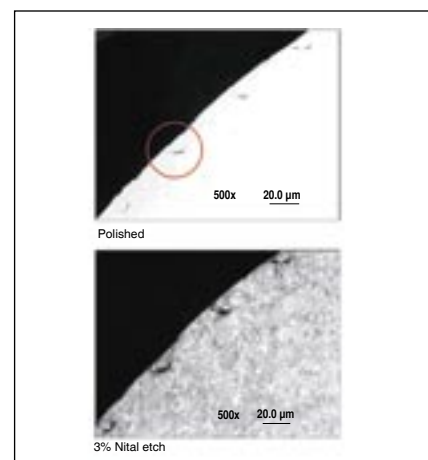
Figure 16—Photomicrograph of Area 5 at 500X magnification. Circle shows surface microcracks.

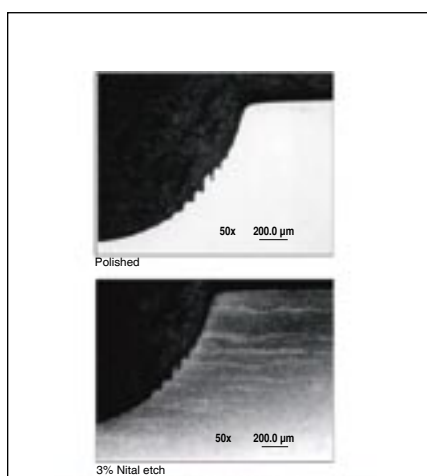
Figure 13—Photomicrographs of Area 2 at 50X magnification showing residual machining lines.

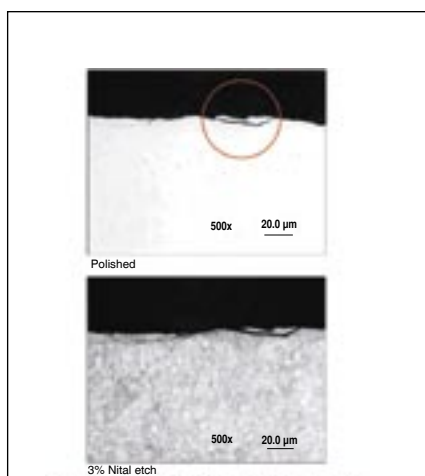
Figure 15—Photomicrograph of Area 4 at 500X magnification showing surface damage.

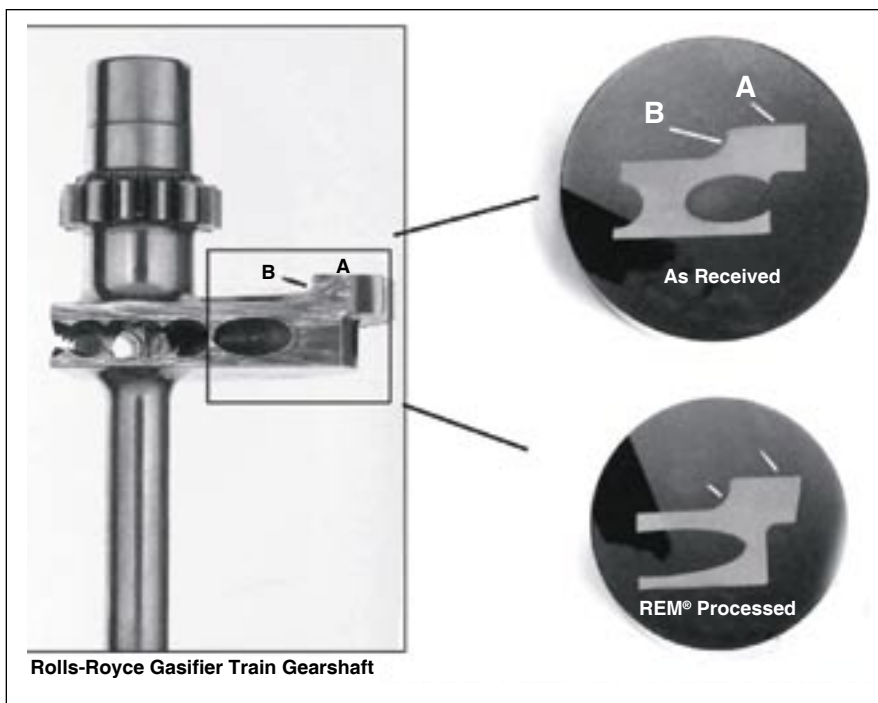
To investigate this concern, Rolls-Royce provided REM with another gearshaft that had IGA for further evaluation (Fig. 18).

Figure 18—Cross-section of gearshaft studied to determine the effect of superfinishing on IGA. IGA was detected on areas A and B.

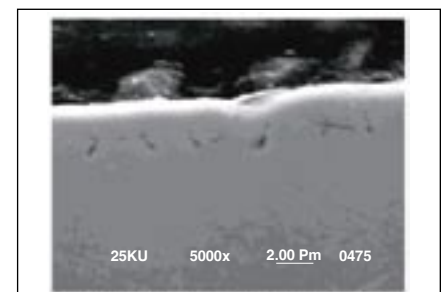
The gearshaft was sectioned, polished, and examined. SEM images confirmed the presence of IGA (Fig. 19).

The maximum nominal depth of the IGA was 0.0002".

Figure 19—SEM at 5000X magnification, showing the presence of IGA. Circle shows a typical IGA crack on areas A and B. The nominal IGA depth is 0.0002".

The gearshaft was then superfinished such that approximately 0.0002" of metal stock was removed. It was then sectioned, polished and examined for the final inspection. The SEM image clearly shows that the layer containing the IGA was completely removed (Fig. 20). The surface at 5,000X shows that it is extremely smooth. This proved that the superfinishing process is not only metallurgically safe, but is also capable of repairing damaged surfaces. However, the depth of the damage must not exceed the metrological tolerance limits of the gear teeth.

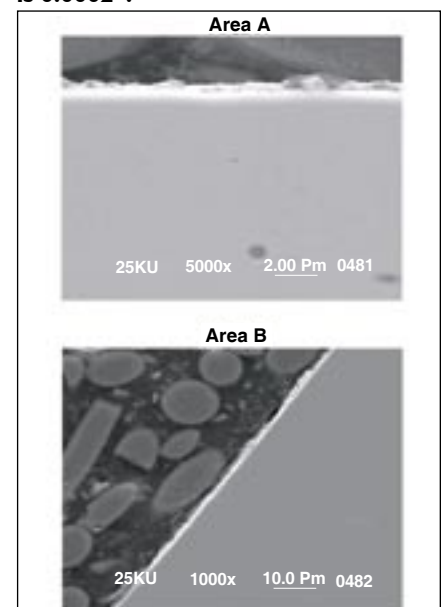
Figure 20—SEM images of Areas A and B showing that superfinishing removed the IGA.
