# White Etching Areas on Case-Hardened Gears

Professor Dr. -Ing. Hans Winter,  
Dr. -Ing. Gerhard Knauer  
Technical University of Munich  
John J. Gamel  
Solar Turbines, Inc., San Diego, CA

## Abstract:

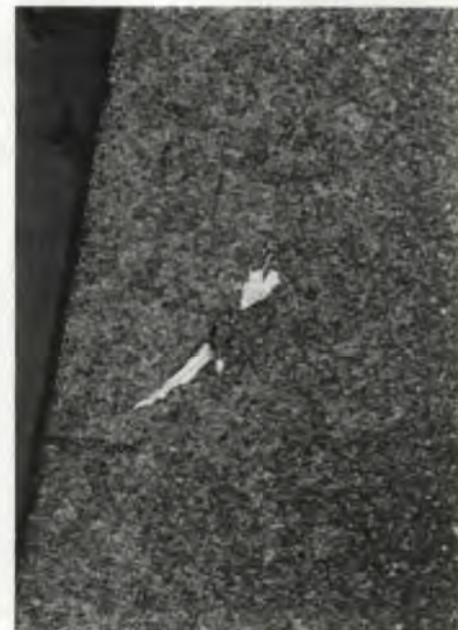
The calculation derived from Fig. 2 is confirmed by Fig. 3. An oxidation inclusion, whose E-modulus is about two times as large as for steel, lies in the area of the inner point of single contact, about 0.14 mm below the surface of the flank in the area of high main shear stress. (See Fig. 1.) In an undisturbed structure, the main shear tension did not reach a value which would be critical for a case-hardened steel. However, the approximate 2.5-fold increase in tension due to the inclusion (compare Fig. 2) led to the occurrence of cracks and WEA, which, in accordance with the path of main shear stress, are approximately  $45^\circ$  with respect to the surface. The gear data and the operating conditions for this experiment are listed in Table 1.

Fig. 3 - WEA starting from an oxide inclusion beneath the flank surface of a case-hardened gear of 16 Mn Cr 5.

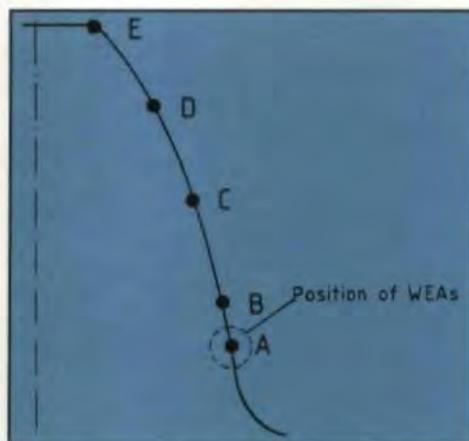
Metallographical examinations show that the greatest number of and the most prominent WEA could be found in this area. (See Fig. 6.)

Fig. 6 – Position of the white etching areas in the area of the beginning of contact on the flank of the driving pinion.

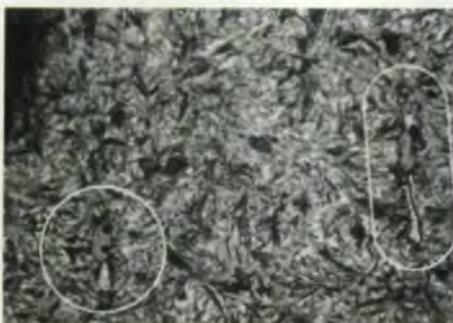
16MnCr5 (See Table 2), with globularly formed sulfide inclusions in which a great number of very small WEA can be noticed in the area of high impact stress. These WEA result exclusively from inclusions; whereas, such occurrences cannot be found with long strips of manganese sulfide. Globular sulfides are harder than manganese sulfides due to combination with the sulfide influencing elements. The cracks that have been examined are never longer than some  $\mu\text{m}$  and never have connection to the surface. (See Fig. 4.) The inclusions themselves are spread out very finely.

Fig. 4 – White etching areas at globular form sulfide inclusions beneath the flank surface.

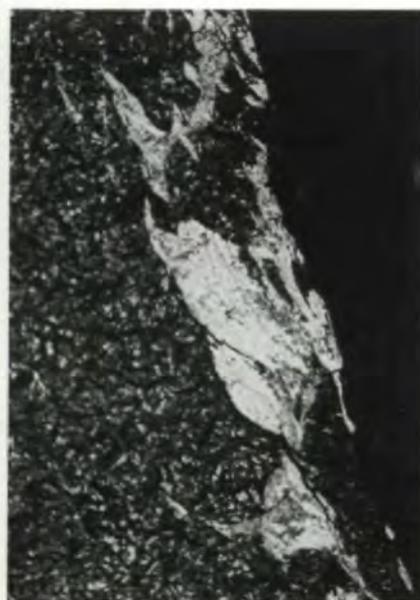
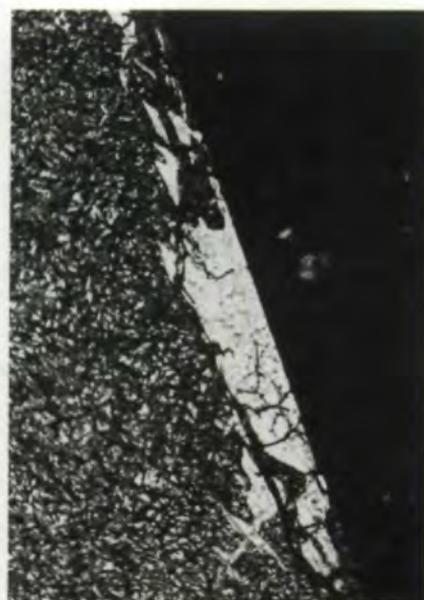
Fig. 7 shows WEA at the surface which have occurred due to high stress caused by the impact shock. Their extension in depth is between 30 and 50  $\mu\text{m}$ . Beneath the surface, the WEA are limited by a crack which runs almost parallel to the surface. Due to the contact shock, there occurs locally high pressure as well as strong friction forces, because of which the flank surface is exposed to an extreme shear stress in this area. Shown in Fig. 8 is the path and the direction of the main shear stress relative to the local pressure on the flank for two friction values as a function of depth from the surface.

Fig. 7 – White etching areas in the area of the beginning of contact on the surface of a case-hardened pinion made of 16 Mn Cr 5.

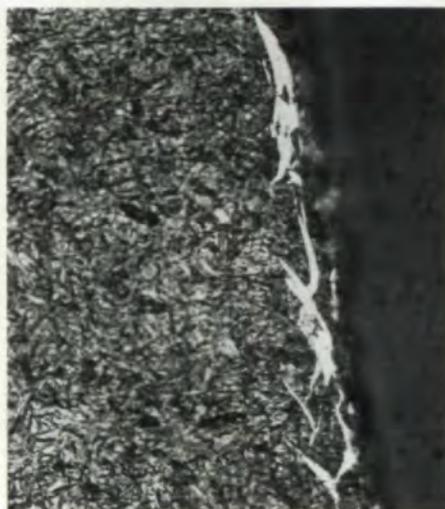
Fig. 9—White etching area in the area of the surface in the direction of the main shear stress.

face. Correspondingly, the angles of the WEA change as is pointed out in Fig. 9.

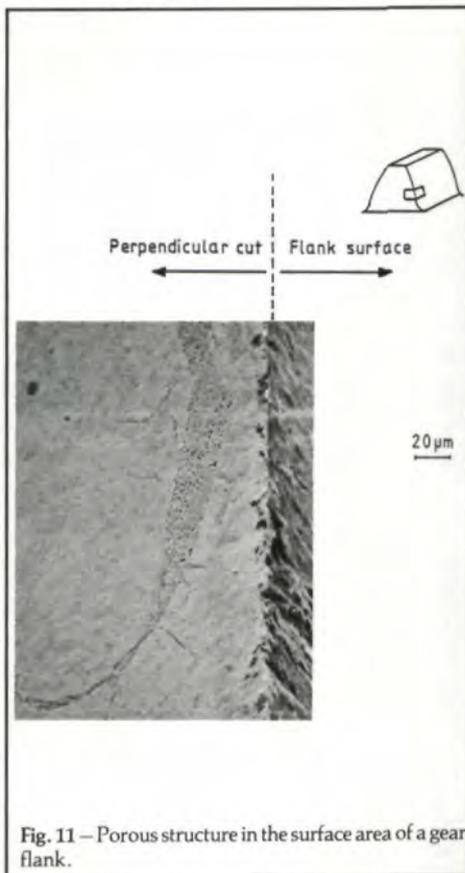
The WEA at the surface examined on the light electron microscope show a partly porous structure which points to a tempering process. (See Fig. 11.) Also, with the light microscope, regions of a darker color can be seen within the WEA. It is still unclear whether within the surface near the WEA, as shown in Fig. 12, such high temperatures can occur that can temper the

Fig. 11 – Porous structure in the surface area of a gear flank.

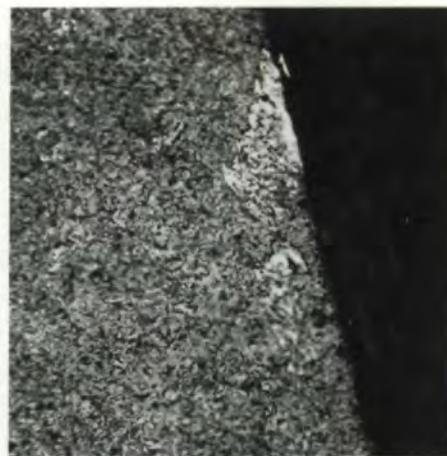
Fig. 12 – Partly tempered WEA at the flank surface.

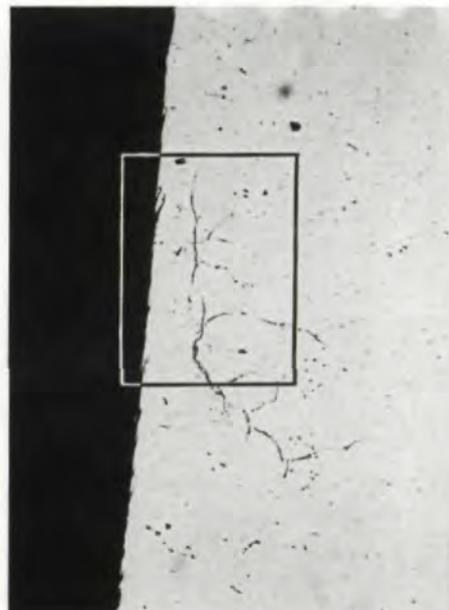
Fig. 13a – Crack near the surface (unetched slide).

Fig. 13a shows a crack beneath the surface of a tooth flank on an unetched slide. Fig. 13b shows the crack at the HNO<sub>3</sub> - etched slide in an area magnification.

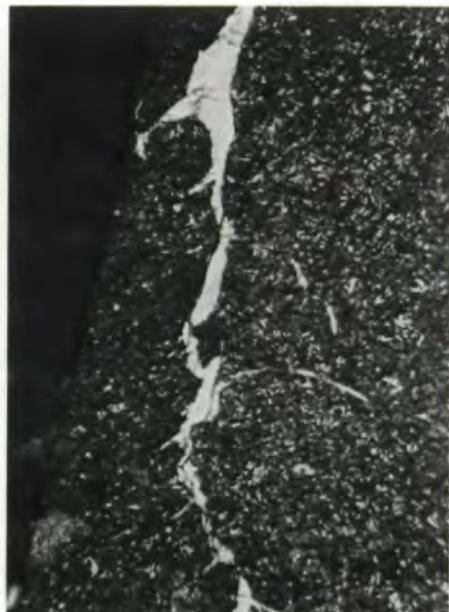
Fig. 13b – View magnification of the crack shown in Fig. 13a that is bordered with white etching area. (Etched with HNO<sub>3</sub>.)

The fact that the crack is bounded with WEA, in accordance with the theory described in Reference 10, points to a very high crack propagation. The question whether the crack has a connection to the surface cannot be answered by just a single plane of a cut; however, we have to assume that such cracks can lead to pitting. Figs. 14 and 15 show slides of tooth flanks of a driving pinion with white etching areas near the beginning of contact and a frontal view of the damaged flank.

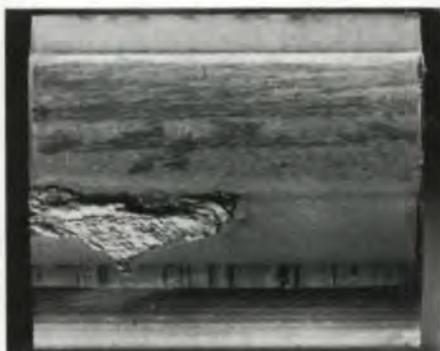
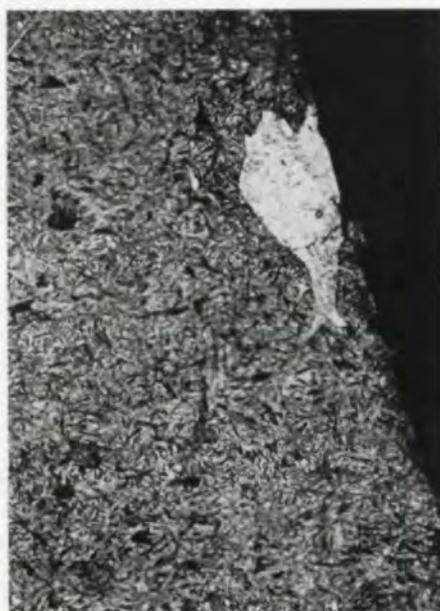
On both pictures, the lower part of the flank is characterized by strong fatigue scratches and pores due to the high stress of the impact shock. Starting in this zone, pitting stretches out in the negative slippage area which caused the failure of the pinion.

Fig. 14 - Flank damage on a pinion. WEA at the surface in the area of initial pitting ( $P_c = 1600 \text{ N/mm}^2$ ).

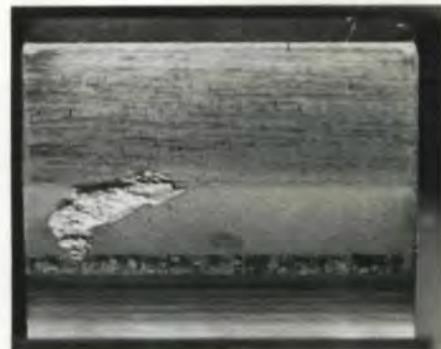
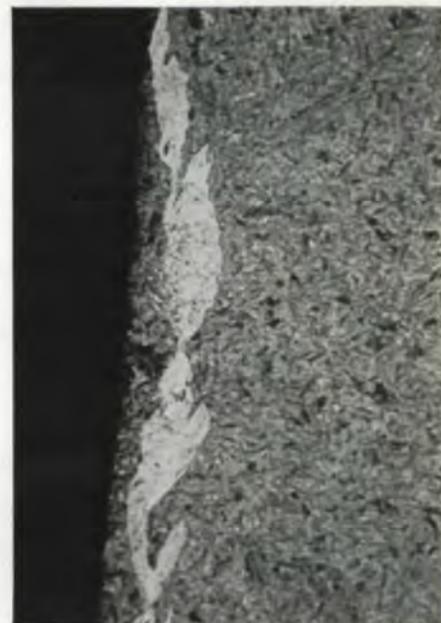
Fig. 15 - Flank damage on the pinion WEA at the surface in the area of initial pitting. ( $P_c = 1560 \text{ N/mm}^2$ ).

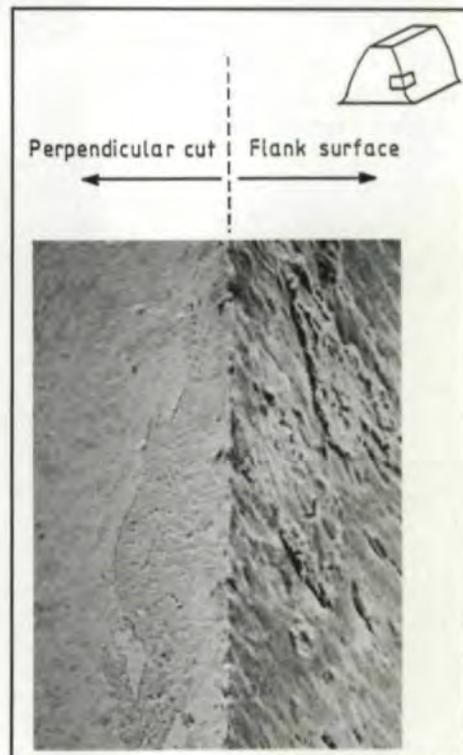
The WEA that are shown as a light electron microscopical picture lie directly on the surface. (See Fig. 16.) In the right half of the picture the strongly fatigued tooth flank around the WEA can be discerned.

Fig. 16 - WEA on the fatigued flank surface of a driving pinion in the area of the first point of initial shock.
