WOOD DESTROYING PESTS AND ORGANISMS INSPECTION REPORT #: 20203171

BUILDING NO. 23922	STREET JUANENO DRIVE	CITY MISSION VIEJO	ZIP 92691	Date of Inspection 05/11/2021	NUMBER OF PAGES 1 of 6
-----------------------	-------------------------	-----------------------	--------------	----------------------------------	---------------------------

APOLLO TERMITE CONTROL INC

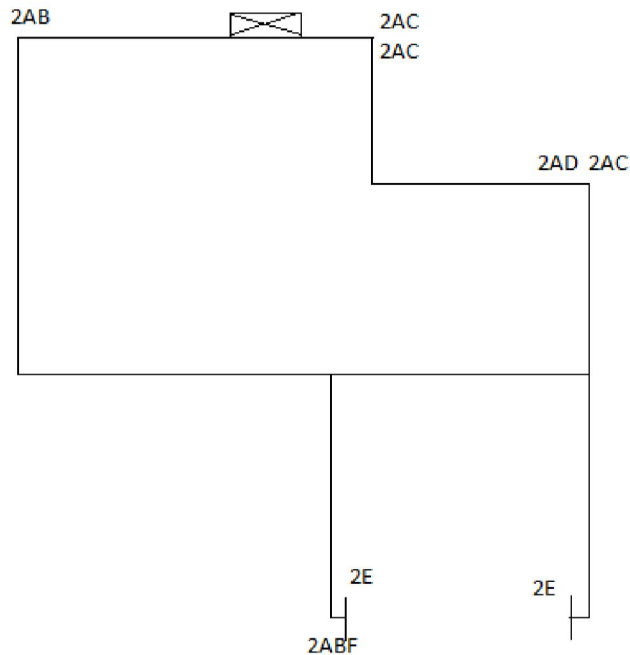
- ITEM NO. 2A** (Section 1)
FINDING: Evidence of drywood termites noted at the eaves. This evidence appears to extend into inaccessible areas.
RECOMMENDATION: 2A Fumigate the structure for the control of drywood termites. Remove or cover drywood termite fecal pellets in accessible areas. Owner/agent to prepare for fumigation as per list of instructions to be furnished by this company. The structure must be vacated until released for re-entry by the licensed fumigator.

- ITEM NO. 2B** (Section 1)
FINDING: Drywood termite damage to the roof sheathing at the eaves.
RECOMMENDATION: 2B Replace the drywood termite damaged starter board.

- ITEM NO. 2C** (Section 1)
FINDING: Drywood termite damage to the fascia board(s) and/or barge board(s) at the eaves.
RECOMMENDATION: 2C Drywood termite damage appears to be minor. Repair damage with wood filler, prime to paint.

- ITEM NO. 2D** (Section 1)
FINDING: Drywood termite damage to the rafter tail(s) at the eaves.
RECOMMENDATION: 2D Drywood termite damage appears to be minor. Repair damage with wood filler, prime to paint.

- ITEM NO. 2E** (Section 1)
FINDING: Evidence of drywood termites noted in the garage. This evidence does not appear to extend into inaccessible areas.
RECOMMENDATION: 2E Fumigate the structure for the control of drywood termites. Remove or cover drywood termite fecal pellets in accessible areas. Owner/agent to prepare for fumigation as per list of instructions to be furnished by this company. The structure must be vacated until released for re-entry by the licensed fumigator.

- ITEM NO. 2F** (Section 1)
FINDING: Drywood termite damage to the fascia board(s) and/or barge board(s) at the eaves.
RECOMMENDATION: 2F Replace the drywood termite damaged fascia board.
