WOOD DESTR	OTING PI	<u> </u>	RGAINISINIS II	NOPECI	ION REPORT		
Building No. / Street	City	Zip	Date of Inspection		Number of Pages		
430 Dennis Drive	Vista	92083	11/23/2020		1 of 6		
LLOYD PEST CONTROL		San Diego	orena Blvd o, CA 92110 625.5991 ution #436	OPERATO HIS/HER F RELATIVE	ED PEST CONTROL OR IS AN EXPERT IN FIELD. QUESTIONS TO THIS REPORT BE REFERRED TO  Report #: 14157		
Ordered by: Kirk Pellow 430 Dennis Drive Vista, CA 92083	Property Owner and/ord Party of Interest Kirk Pellow 430 Dennis Drive Vista, CA 92083			1	Report sent to: Kirk Pellow 430 Dennis Drive Vista, CA 92083		
Complete Report	imited Report  Supplemental Report			Reinspection Report			
General Description: Occupied Single Family One Story Detached Garage					Inspection Tag Posted:  Other Tags Posted:		
Raised Foundation with Composition Roof  An inspection has been made of the structure(s) shown on the diagram in accordance with the Structural Pest Control Act. Detached porches, detached steps, detached decks and any other structures not on the diagram were not inspected.

Building No. / Street	City	Zip	Date of Inspection	Number of Pages
430 Dennis Drive	Vista	92083	11/23/2020	2 of 6

# **Findings And Reco

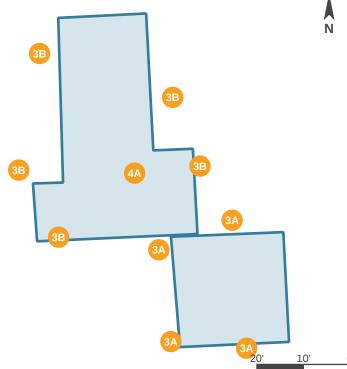
Evidence of drywood termites found in areas marked on diagram.

Fungus damaged wood found in eaves marked on diagram. Door jamb.

Fungus damaged wood found in eaves marked on diagram.

Water damage found in areas marked on diagram.

Cover entire structure(s) and fumigate with Sulfuryl Fluoride for the elimination of drywood termites. Chloropicrin will be used as a warning agent. Cover or remove accessible termite pellets. Lloyd Termite Control Company assumes no responsibility for damage to any plant life or roofing caused by fumigation operation.

Remove and replace fungus damaged wood as needed. Painting is included in this estimate. If damaged wood extends into concealed or inaccessible areas, cost of repair will be in addition to estimate given.

Owner to contact a licensed contractor to make necessary repairs.
