## The Path of Least Resistance— Roller Bearing Damage in VFDs

## Norm Parker

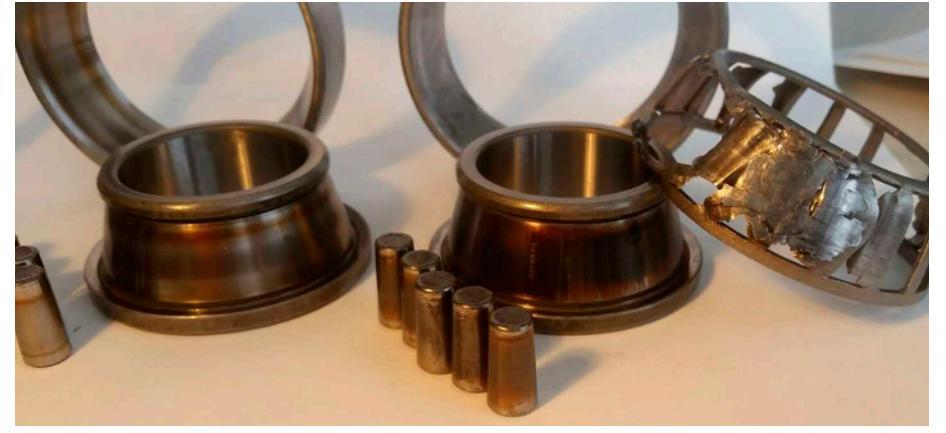
Rotor to ground current is often damage caused by an improperly grounded test cell.

Image 1—Bearing Failure from an improperly grounded test cell.

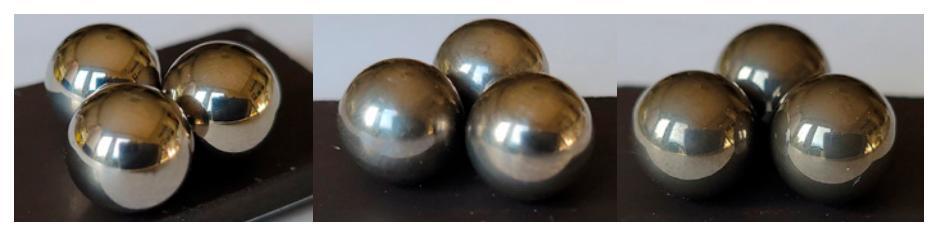
Figure 7—A Range of Ball Conditions: 7a (new), 7b (light dulling), 7c (opalescent).

It is important to understand that not all electrical damage looks the same. We can see everything from a minor dulling of ball sheen to full tactile—audible noise—fluting. Does the theory match reality? Can stray motor currents find their way to the gearbox? They absolutely can. In real testing with unprotected motor and gearbox bearings, a unit was exhibiting gearbox bearing noise signals. Upon inspection, Bearing 2 had clear indications of light fluting (could not feel with bare skin, but was picked up on vibration) along with the elusive "tiger stripes" found on the input gear.

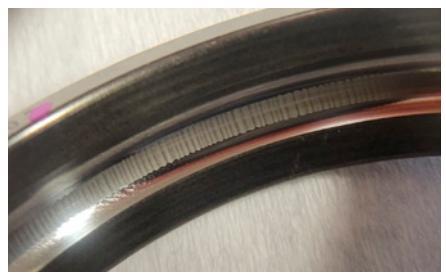
Figure 8—Heavy tactile fluting on motor bearing (picked up on vibration sensor).

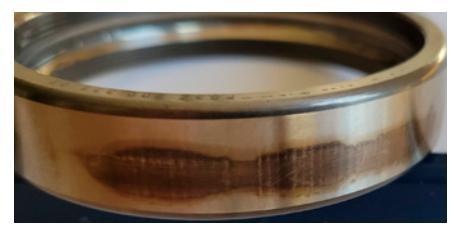
Figure 9—Outer Race of Electrically Damaged Motor Bearing.

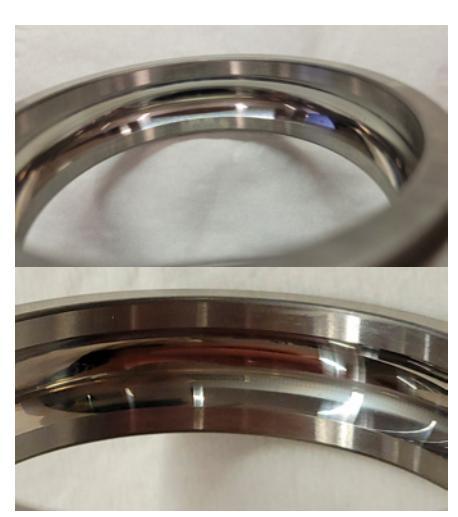
If we assume our capacitance model is correct and we have enough shaft current to damage a bearing, we can see that, under load, there is potential for the current to travel through Bearing 2 as it has the highest pressure.

Figure 10—Light Fluting on Bearing 2.

Finding these early signs of damage gave an early clue that our gearbox was not properly protected and allowed adequate time to implement the corrections. Had these indications not been found early on by looking at the gearbox side, it could have risked launch timing down the road.

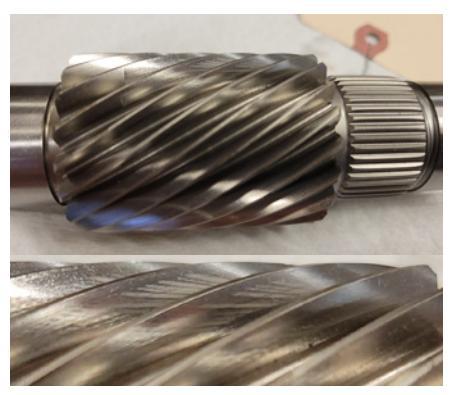
Figure 11—Tiger Striped Input Gear.
