Systems Failure

Rethinking failure, replacement, and supply strategy in heavy industry

Pamilanga Ltd.

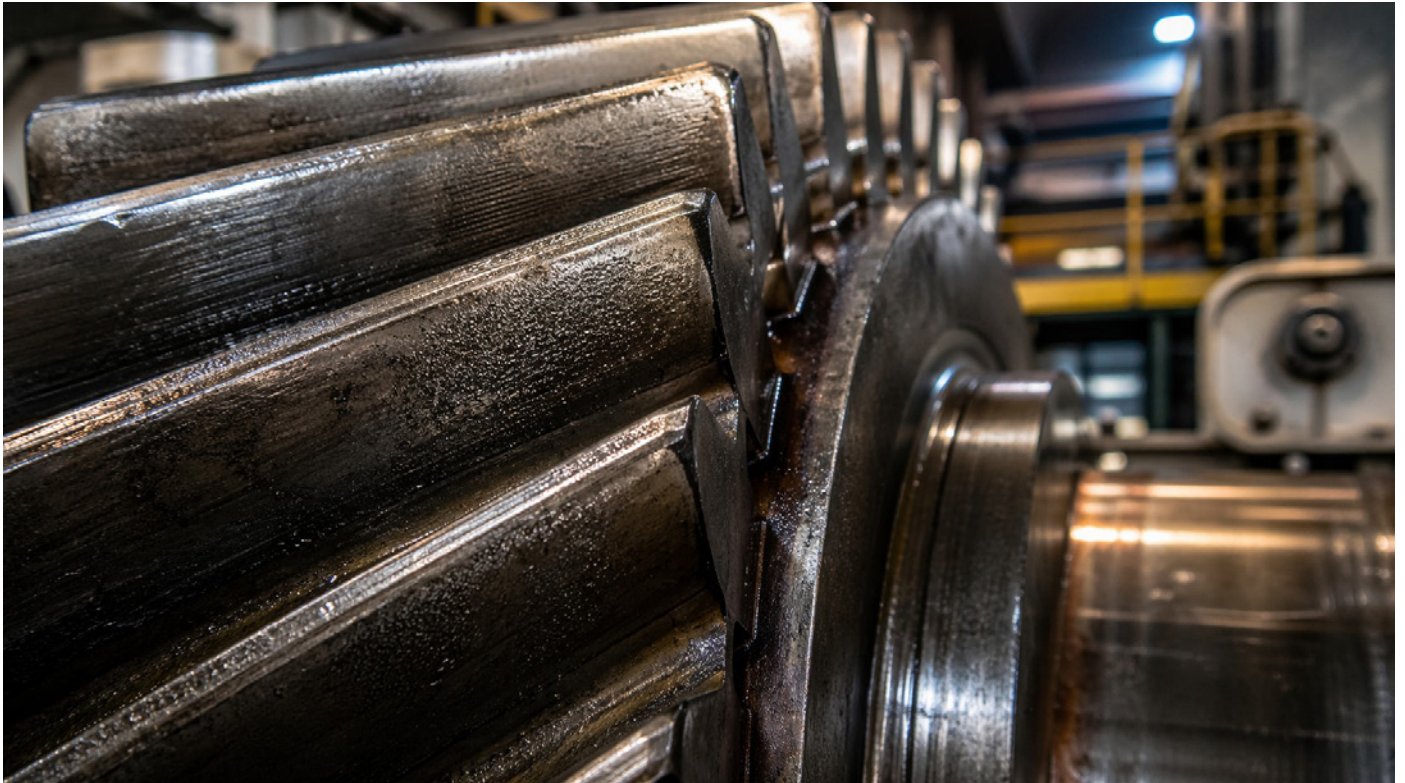
Figure 1—Early-stage surface fatigue and distress on a heavy-duty gear tooth flank. Surface damage may progress well before catastrophic failure becomes visible. (All Images: Pamilanga Ltd.)

Early-stage gear distress is typically progressive rather than catastrophic. Micropitting is one of the clearest examples. Under mixed or boundary lubrication, local asperity contact causes repeated surface fatigue at a very small scale. The damage may first appear as a dull grey patching effect on the active flank, usually near the pitch line or in areas where contact has shifted away from the intended load zone. Operators may continue running because the gear still looks serviceable and the machine has not yet tripped. But once the surface is disturbed, local stress concentration

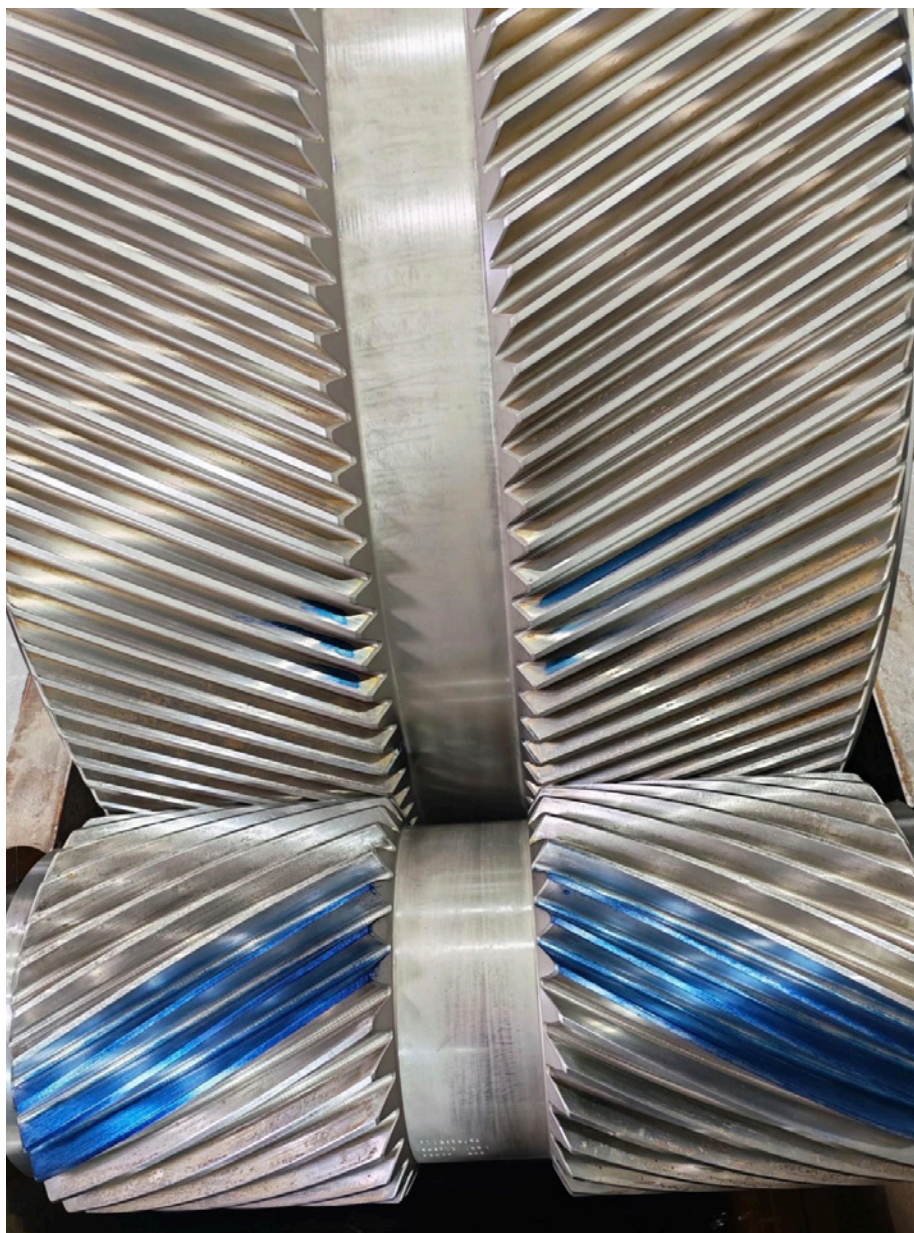
Figure 2 – Contact pattern verification on helical gear teeth. Blue marking compound highlights the actual contact area across the tooth flank. Uneven patterns may indicate edge loading, alignment deviation, or load distribution issues before visible gear damage occurs.

Misalignment is the most common hidden amplifier. It does not have to be dramatic to be damaging. A contact pattern that migrates toward one side of the face width creates local overload, changes the oil film behavior, and raises tooth root stress. The source may be shaft deflection under torque, pedestal movement, bearing wear, housing distortion, soft foundation response, assembly error, or thermal growth between cold alignment and hot operating conditions. In large mill drives and heavily loaded reducer stages, this distinction is critical: the measured alignment at standstill may not represent the alignment under process load.

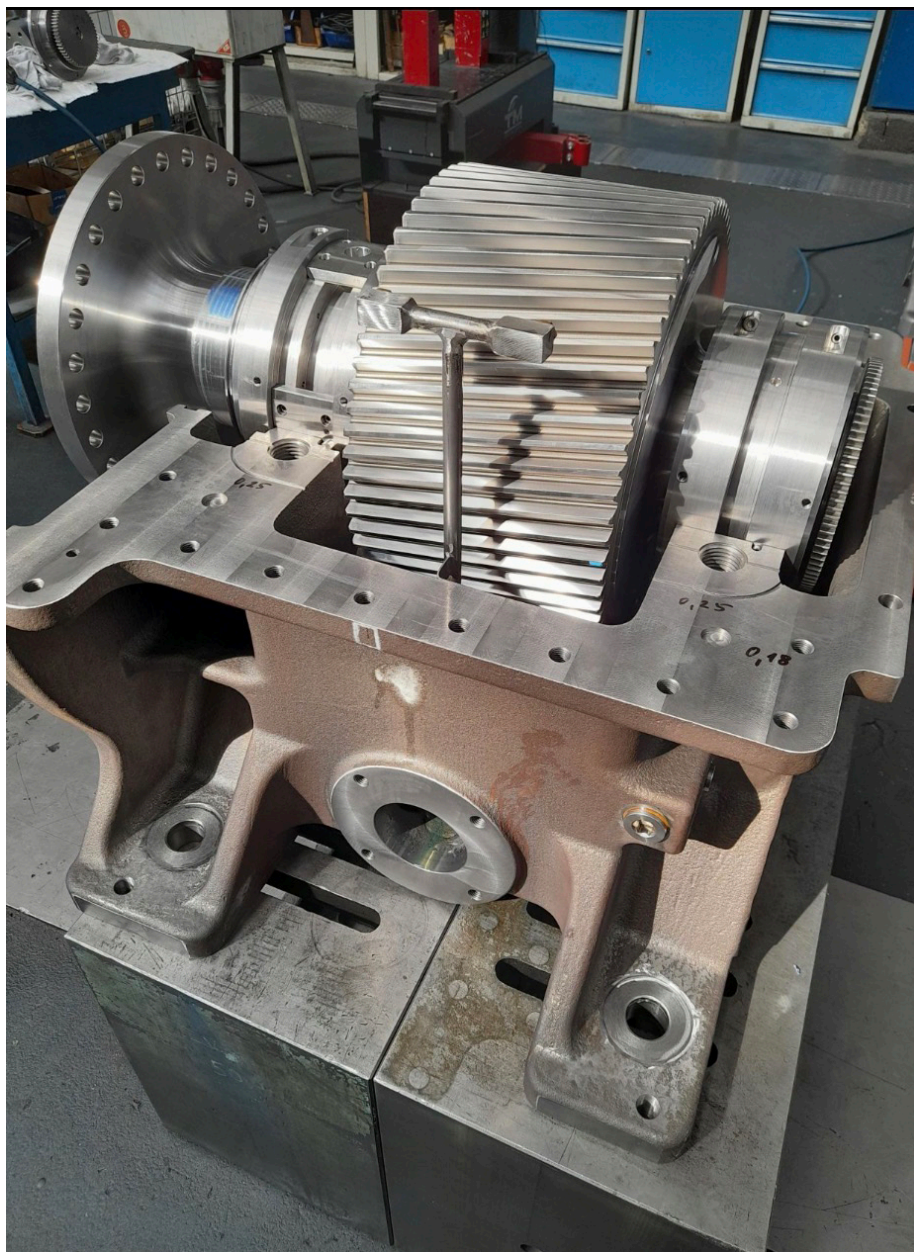
Figure 3 – Gearbox assembly under inspection. Heavy-duty gear and shaft assembly during fitting and inspection. Long-term reliability depends on evaluating the complete system rather than replacing the gear alone.

Finally, replacement planning has to include installation and startup discipline. Contact checking, alignment verification, lubrication readiness, controlled commissioning, and early inspection intervals are part of the replacement strategy not an afterthought. A technically correct gear installed into an unchanged misaligned train is still a vulnerable gear.
