Problem with Disk Pack Coupling

THE QUESTION

EXPERT RESPONSE PROVIDED BY Robert Errichello.

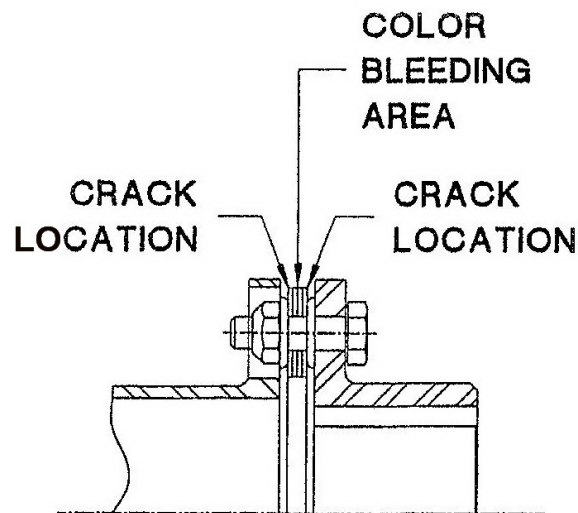
1. Reddish brown color bleeding out between disk laminations at the outside diameter (OD) of the disk pack. This indicates fretting corrosion due to loose bolts or chemical attack. See Figure 1.

2. Fine line crack starting in the outer disk tangent to the washer (OD). This indicates a fatigue failure due to excessive misalignment. See Figure 1.

Figure 1 Fatigue failure due to excessive misalignment.

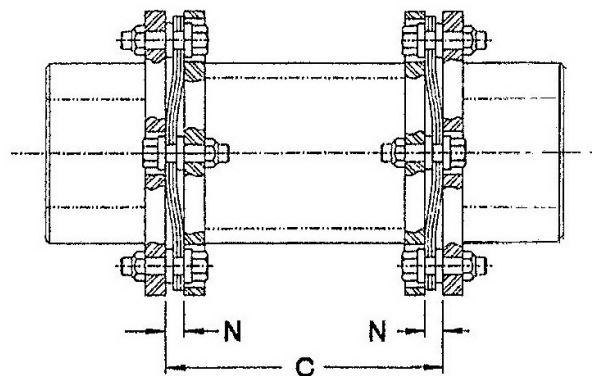
3. The disk pack is wavy and the dimension "N" between flange faces is smaller than indicated on the installation instructions or applicable assembly drawing as shown in Figure 2. The coupling has been installed in a compressed condition or equipment has shifted axially during operation. Check for thermal growth problems. If the application has a sleeve-bearing motor, make sure that the operating centerline of the motor rotor is properly positioned. Realign the axial position of the equipment to relieve disk pack compression during operation.

Figure 2 The disk pack is wavy and the dimension "N" between flange faces is smaller than indicated on the installation instructions or applicable assembly drawing.

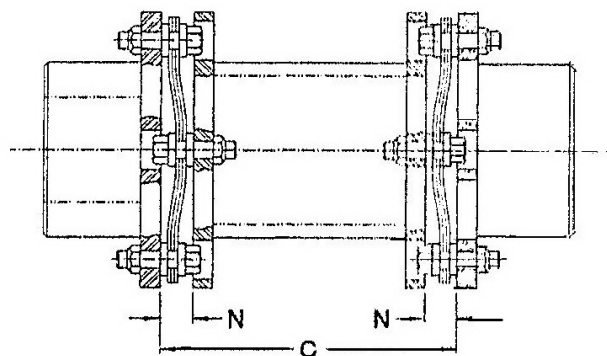
4. The disk pack is wavy and the dimension "N" between flange faces is larger than indicated on the installation instructions or applicable assembly drawing as shown in Figure 3. The coupling has been installed in an elongated condition or equipment has shifted axially during operation. Realign the axial position of the equipment so

Figure 3 The disk pack is wavy and the dimension "N" between flange faces is larger than indicated on the installation instructions or applicable assembly drawing.

that the coupling operates with a neutral flat disk pack. If the application has a sleeve-bearing motor, make sure that the operating centerline of the motor rotor is properly positioned.

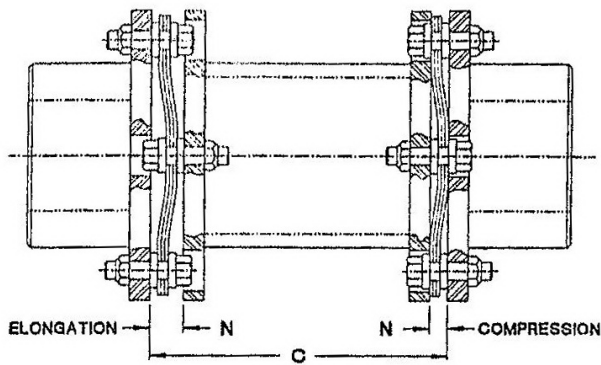
Figure 4 Wavy disk packs on both ends of the coupling. One end is compressed, and the other is elongated.

5. Wavy disk packs on both ends of the coupling. One end is compressed, and the other is elongated. See Figure 4. This is called "oil canned" disk packs. The disk pack has no neutral center where it remains flat and parallel with the end flanges. Loosen all locknuts, correct the axial spacing, and tighten the locknuts. If this doesn't resolve the problem, the disk packs might have been permanently deformed. Replace the disk packs and reassemble the coupling.

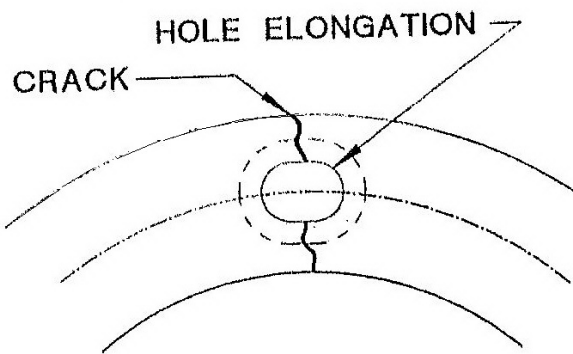
Figure 5 The disk is broken through the bolt hole.

1. The disk is broken through the bolt hole as shown in Figure 5. This indicates loose coupling bolts. Replace the disk pack and tighten locknuts to the specified torque.

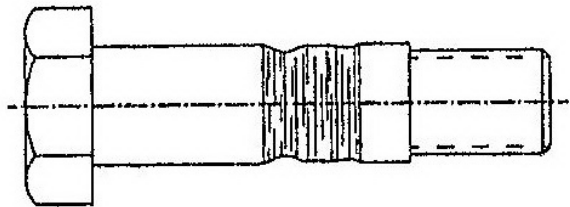
Figure 6 Do not turn the bolt during the locknut tightening process.

2. Disks are embedded in the bolt body. This is usually the result of a loose bolt or severe torque overloads. This can also appear when turning the bolt during installation. Replace the bolt and tighten the locknut to the specified torque. Do not turn the bolt during the locknut tightening process. See Figure 6.

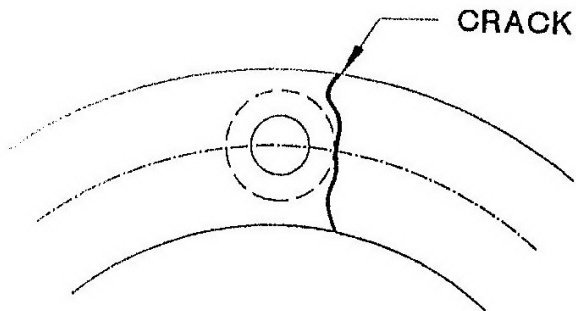
Figure 7 Excessive misalignment during operation.

3. Disk is broken adjacent to washer face. Cracks usually start in the outermost disk and progress through the disk pack. This indicates excessive misalignment during operation. See Figure 7. Replace both disk packs and realign the equipment. Make a hot check of alignment to ensure it is within the coupling specification.

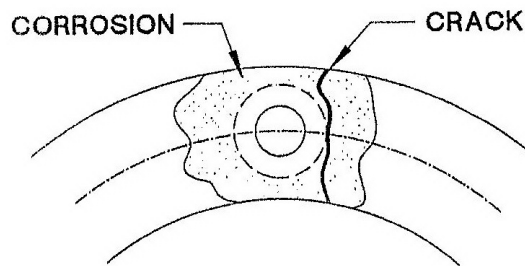
4. Disk is broken adjacent to washer face with fretting corrosion in the area of the crack. This indicates excessive misalignment during operation. See Figure 8. Replace both disk packs and realign the equipment. Make a hot check of alignment to ensure it is within the coupling specification.

Figure 8 Disk is broken adjacent to washer face with fretting corrosion in the area of the crack. This indicates excessive misalignment during operation.

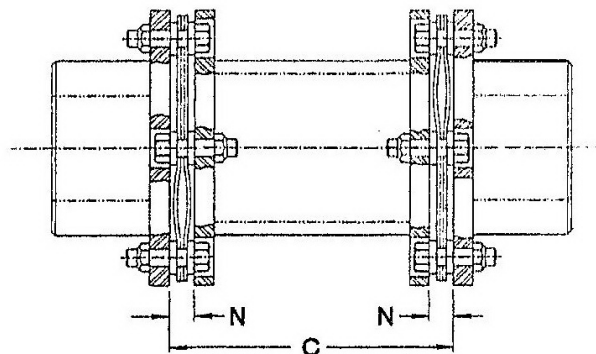
5. The disk pack has a bulge between the bolts, or is bowed toward one flange in alternate chord positions as shown in Figure 9, bolts are bent, or bolts are damaged as shown in Figure 6. This condition is a result of a large torque overload induced into the system above the peak overload capacity of the coupling. The remaining disk pack chordal sections will be very straight and tight. If the bulge appears in only one chordal section, there might be a loose bolt on one side of the distortion. Loosen all locknuts and unseat the bolts. The bulge should release and flatten out. If so, retighten the locknuts. If the distortion does not disappear, replace both disk packs and retighten the locknuts. If there is a synchronous motor driver, measure the startup torque at the motor shaft with strain gages to determine if torsional resonance causes overload torque that exceeds the peak torque capacity of the coupling. Check the coupling selection and apply the proper size and type of coupling for the characteristics of the application.

Figure 9 The disk pack has a bulge between the bolts, or is bowed toward one flange in alternate chord positions.
