# Nanocomposite Coatings for Gears

Dr. Peter L. Schmidt, P.E. and Brady Blomquist

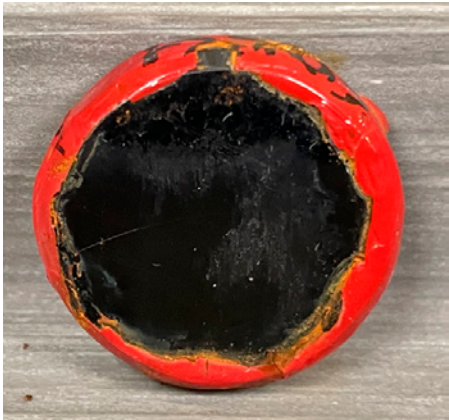
Figure 15—Test coupon F2703 after 1,341 hours of salt fog exposure.

Subsequent development of the adhesion layer and surface modification used with this coating recipe has yielded significant, consistent corrosion resistance performance for the coating system. Figure 15 shows a coupon manufactured from AISI 4140 steel. This coupon was removed from long-term testing to clear the chamber for new work. Based on the latest test results, the coating is rated for 1,000+ hours of salt fog exposure.

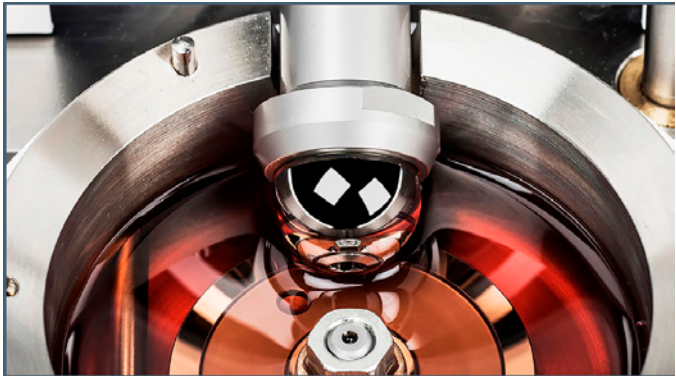
Figure 19—Commercially available ball on disc test cell (Ref. 18).

Additional testing was done with an alternate method. A ball-on-disc method was employed to better control the contact surfaces’ relative velocity. This test allows the user to specify the amount of sliding present at the contact interface where both sliding and rolling occur. In involute gear teeth, the contact is perfect rolling at the pitch diameter, with varying amounts of sliding in the rolling direction and in contrast to the rolling direction during every tooth contact event. A commercially available ball-on-disc scuffing test cell is shown in Figure 19.

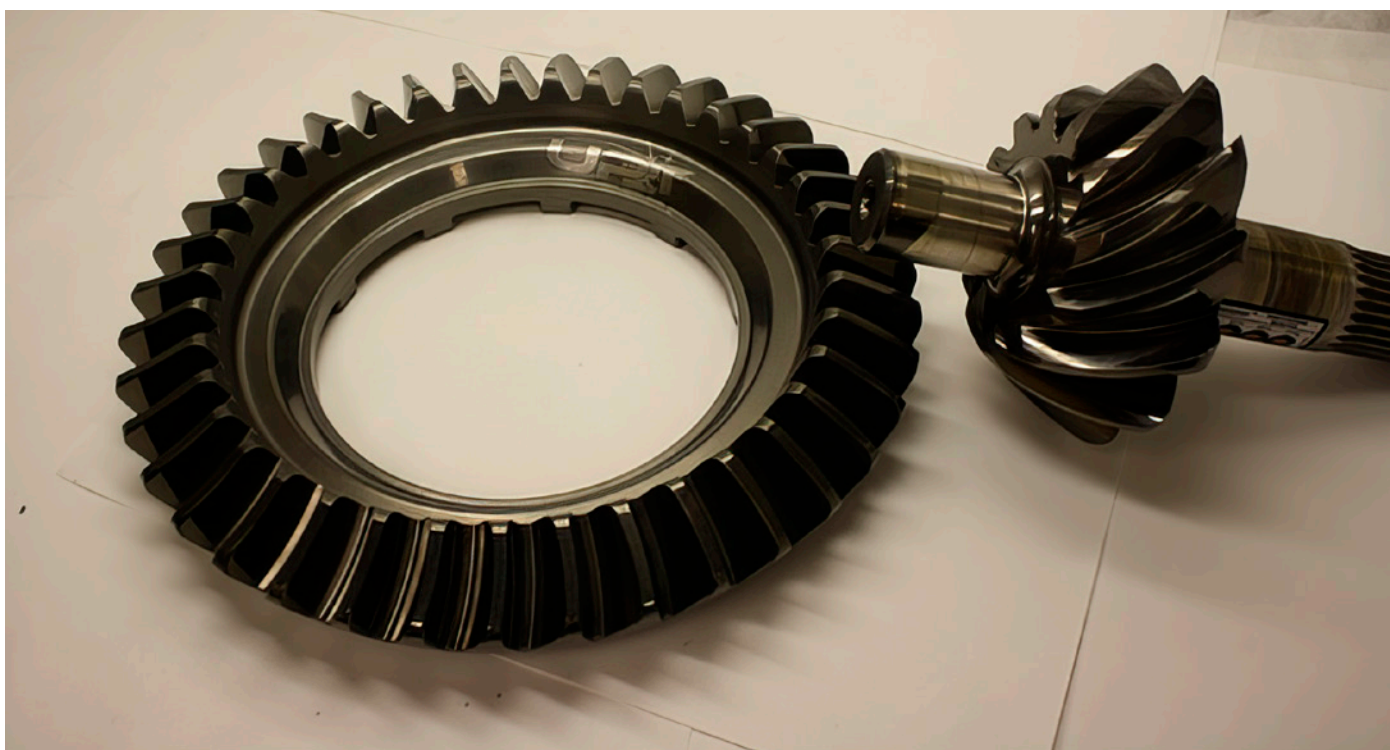
Figure 24—Ring gear and pinion from a competitive racing team, coated with the predecessor of the P51M coating system.

This project was inspired by work done for a competitive racing team operating in an environment where any edge in performance is valuable and where significant engineering effort is expended to obtain such performance advantages. The ring and pinion for this project are shown in Figure 24. It should also be noted that a similar arrangement is being developed for UAV applications.
