Globalization's Effect Upon Gear Steel Quality

Background on development of high-speed, automatic hardness tester

Aizoh Kubo

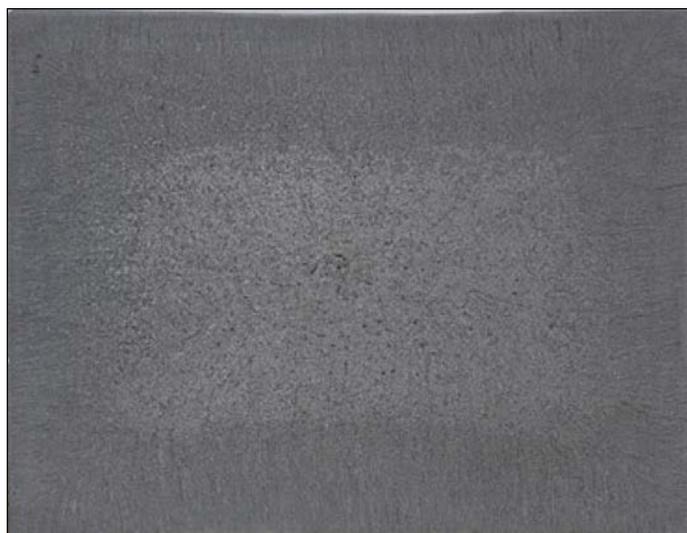
Figure 4 Cross-section of steel bloom just after congealed state in CC production.

Figure 4 shows a macro-etched cross-section of a steel bloom obtained by cutting the bloom just after its congealed state in continuous casting production. There are many impurities, voids, etc. in the central part of the bloom. The steel bar that we usually use for gear production is made from such a bloom via the press-rolling process, which means that the steel texture remains almost the same as that of Figure 4. When the amount of discarded steel reduces to help offset economical steel production cost, some amount of agents for refining—like Al, Si etc.—remain in final-state steel bar available on the market. Figure 5 shows a cross-section of a CrMo steel blank of 800 mm

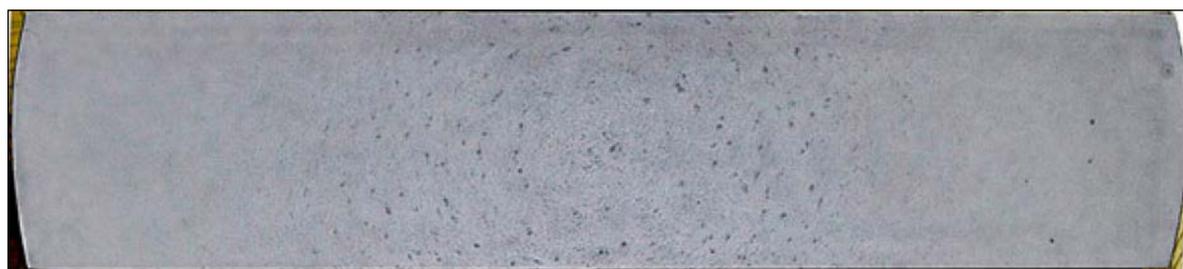
Figure 5 Macro-etched figure of a cross-section of CrMo steel bar of 800 mm diameter.

diameter for gears. Around the center of the blank, segregated impurity and voids are distributed in circular fashion. Each part of the segregation has considerable length in the axial direction of the blank. Figure 6 shows a macro-etched figure of rectangular CrMo steel slab of 500 mm side length. The left edge is the surface of the rectangle slab, and ca. 1/3 from the right edge is the center of the slab. It is clear that the state of crystallization and impurity distribution at both the periphery and center of the slab are different. Surely the strength or the durability of the material is considerably different at the peripheral or middle of the cross-section and at the central part. But the gear designer calculates the load-carrying capacity of gears using the same value for the material strength that is typically indicated by the specification of the steel.

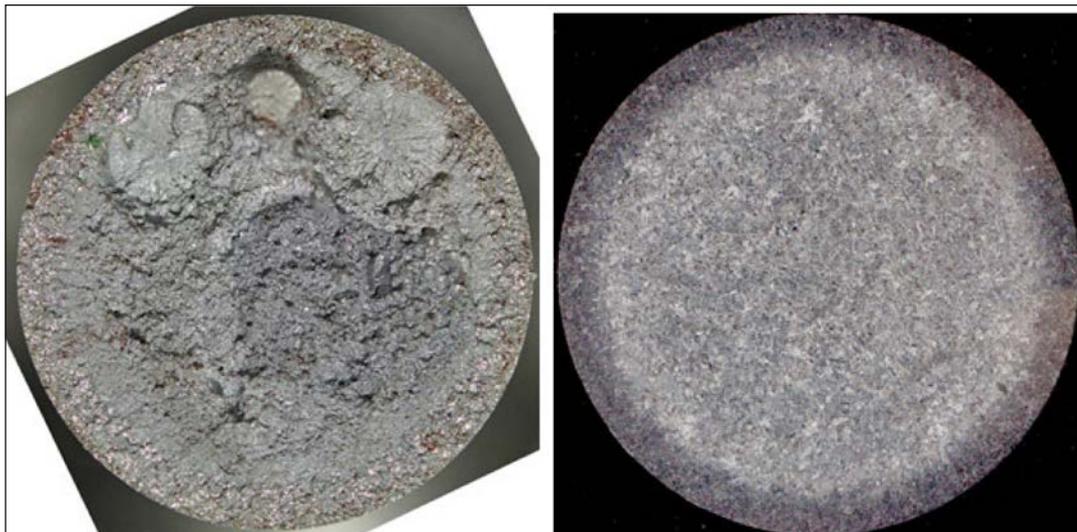
Figure 8 Segregation found in fatigue fracture surface and the polished and etched figure.

Figure 8 (left) shows the fracture surface of a case-hardened SCM420H steel bar specimen; a test was conducted (Ref. 1). In the cross-section a great deal of hard-to-explain segregation is observed. The test piece was cut at 2 mm; a partial specimen from this fractured section was polished and nital-etched; the (Fig. 8, right) figure shows the result. The figure appears here in the same angular position as the (Fig. 8, left) figure. In observing this etched surface it is difficult to determine that this specimen contains such a robust segregation

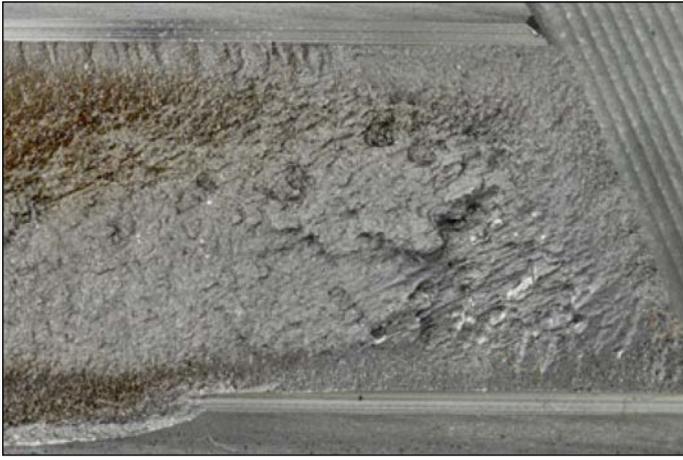
Figure 9 Cluster forming of impurity particles in gear steel.

Figure 9 shows an example of an undesirable state of existence of impurities in steel matrix, i.e. — they gather and form a cluster. Also in this material some thin layers of MnS exist (Fig. 9, lower right). You can see the oblique ridges of material in the fractured section. When a cluster of hard particles exists in the material, just beneath the surface, and the surface is loaded with heavy contact, the state of shearing stress induced between the particles in the cluster differs from that of homogeneous material. The shearing stress between hard particles in the cluster becomes higher than normally induced stress value (Fig. 10), and micro-crack can initiate there rather easily. Such micro-cracks are thought to be a trigger for the development of *macro*-crack, which leads to the fracture of, for example, gear teeth. Figure 11 (left) shows a fractured surface of gear tooth broken in the endurance test. In (Fig. 11, lower left) a cluster of impurity particles is found just under the tooth flank. A helical gear was made from the same material, of the same lot, and an endurance test was conducted under the maximum contact pressure of 2.3 GPa. Until 3×10^7 loading cycles, all tooth flanks showed no sign of failure initiation. At 3.7×10^7 loading cycles, there appeared suddenly a big and deep spalling of tooth flank. On the bottom of the crack cavity a cluster of foreign objects was observed. Other tooth flanks of this gear are all OK and look quite healthy. There is no sign of surface failure (Fig. 11, right).

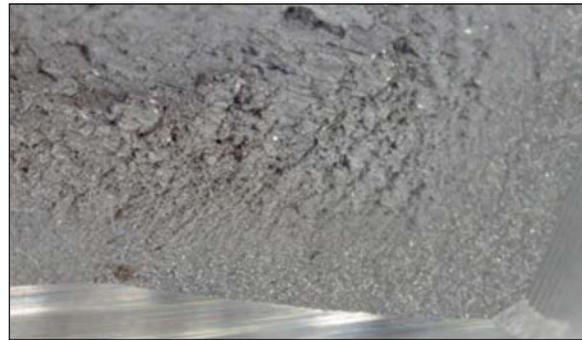
Figure 11 Cluster of impurity particles just under the tooth flank. Sudden spalling of tooth flank.

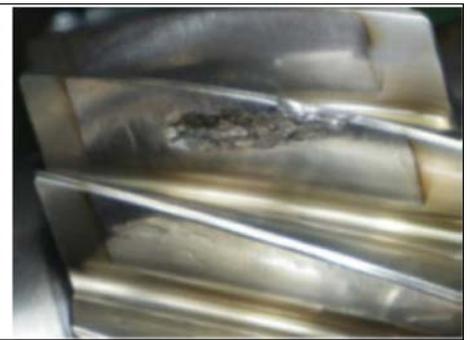
Figure 10 Possible micro crack initiation in a cluster of inclusion.

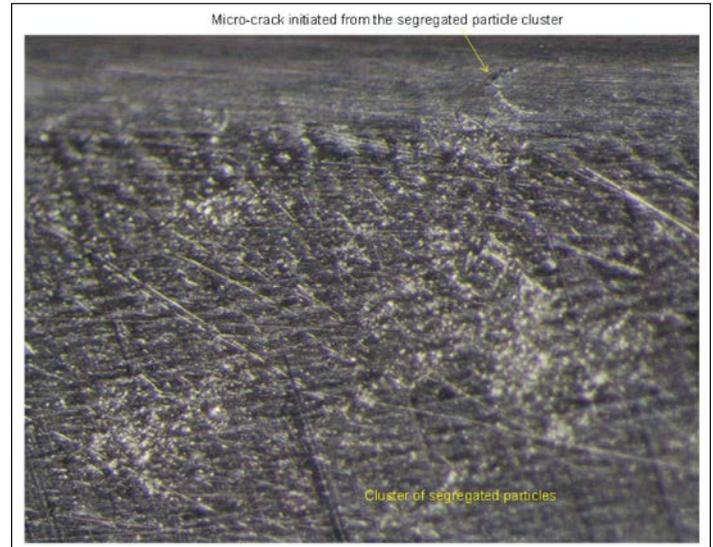
Figure 12 Cluster of impurity particles appeared on tooth flank from which a fatigue crack initiated.

On another tooth flank of the same gear, a cluster of impurity particles was found on the surface of the tooth flank (Fig. 12); a fatigue micro-crack initiated from that impurity cluster.
