# Gear Oil Micropitting Evaluation

A. B. Cardis & M. N. Webster

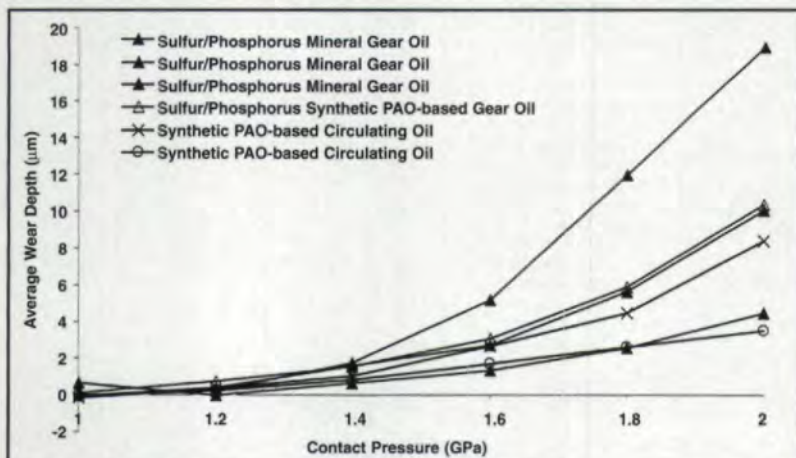
Fig. 1—Plot showing the progression of micropitting wear during Roller Disk machine experiments for various ISO VG 100 industrial gear and circulating lubricants.

The variable load method as described in reference 4 has been used to investigate the effect of lubricant composition on micropitting. Figure 1 shows results obtained from the tests conducted using a series of ISO VG 100 industrial gear lubricants. The two sulfur-phosphorus gear oils contain the anti-wear and anti-scuffing additives required to provide Timken OK load results greater than 60 lbs. The synthetic PAO based circulating oil was formulated to provide FZG fail stage 11 scuffing protection but does not provide a high level of Timken OK load protection.

Despite the scatter associated with the mineral gear oils, the results show that both the mineral and synthetic based gear oils yield similar results. The results for the synthetic PAO circulating oil suggest that the use of less aggressive anti-wear additive systems provides directional improvement in micropitting performance. The results from these gear oil tests compare well with results obtained with the same lubricants using the FVA micropitting gear test and suggest a good correlation between the roller disk machine and FVA test methods.

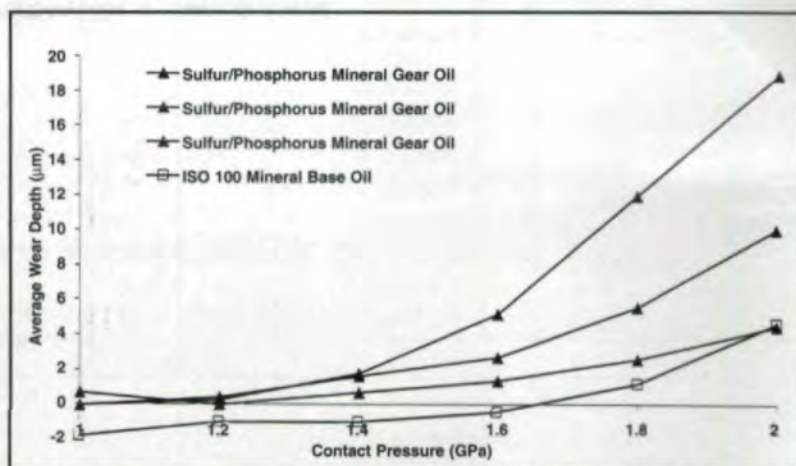
Fig. 2—Average wear depth results from Roller Disk tests show the effect of removing additives from an ISO VG 100 sulfur-phosphorus gear oil.

To further investigate the influence of additives on micropitting, a test was conducted on the unaditized mineral base oil used in the mineral gear oil test. The results are compared with the fully formulated gear oil in Figure 2. The onset of micropitting is delayed and the final result corresponds to the lowest of the three fully formulated gear oil results. This result confirms the significant impact that lubricant additives can have on micropitting.

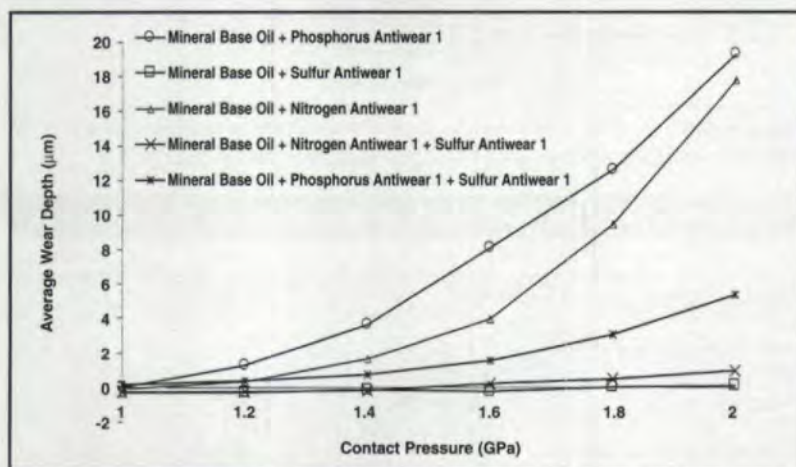
Fig. 3—Roller Disk Machine micropitting test results showing the influence of individual additive components from a typical ISO VG 150 sulfur-phosphorus-based gear oil package.

In order to gain an understanding of the impact of different component technology, micropitting tests were conducted on different combinations of additives and base stocks. In a first series of tests, individual components and combinations typically found in conventional sulfur-phosphorus gear oils were tested in ISO VG 150 mineral base stock. The results shown in Figure 3 indicate that the sulfur based antiwear additive 1 does not promote micropitting. Comparing against the mineral base stock results from Figure 2, we find that it may even improve upon base, stock-only performance. Both the nitrogen and phosphorus antiwear additives showed a significant tendency to produce micropitting. The addition of the sulfur antiwear to either of these two resulted in a significant improvement in performance. From these results it was concluded that sulfur additive 1 acts in some way to reduce micropitting damage. However, results from mixtures are not necessarily the sum of the results gained on individual components so the benefit from the use of sulfur additive 1 may not be reproduced when combined with additional additive technology.

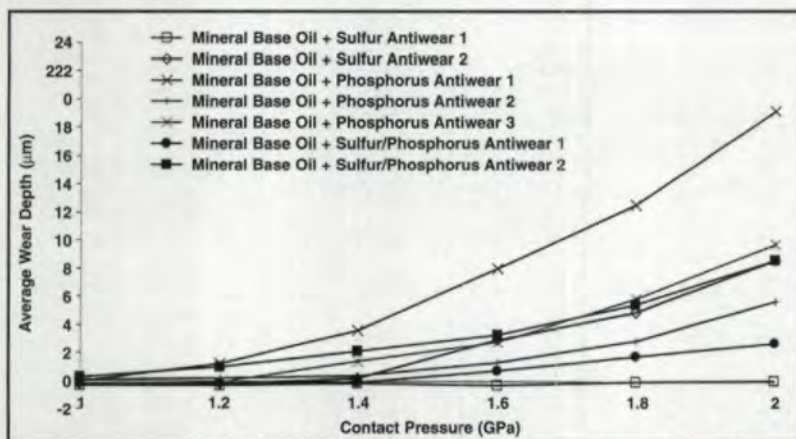
Fig. 4—Roller Disk Machine micropitting results for a range of alternative sulfur- and phosphorus-based antiwear additives blended into mineral base stocks.

In a second series of tests, the performance of a range of alternative sulfur- and phosphorus-based antiwear additives were evaluated and the results are shown in Figure 4. In this case, we see that there is a variation in the response within a general category of additive. For example, sulfur additive 2 resulted in a greater degree of micropitting than found for sulfur additive 1. Similar variations are found for the phosphorus and mixed sulfur/phosphorus additives tested. The results show that there is a large variation in the micropitting performance of the anti-scuffing additives that can be used to formulate gear oils. This variation is, no doubt, a function of the individual additive chemistry and it would be dangerous to assume, based on our limited testing, that any one class of additive has an advantage over another.

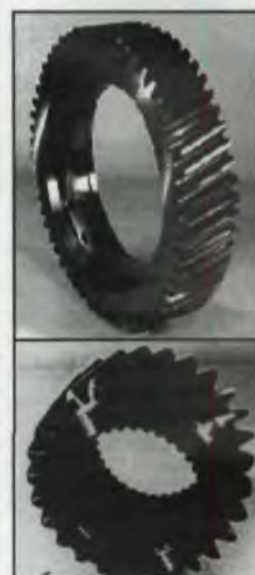
Fig. 5—Pictures showing the 55-tooth gear and 25-tooth pinion used in the helical gear testing.

Following the roller disk machine experiments, a program was embarked upon to develop a micropitting resistant gear oil. The formulation effort made use of the FVA test as the primary tool for the evaluation of micropitting performance. However, additional testing was also conducted on larger gears more representative of commercial industrial gears. A test program was developed using an available four square gear test rig. In a further development, an automated machine vision system was employed to provide accurate and repeatable measurement of the micropitting areas on the test gears. Information about the gears and test conditions may be found in Table 2 and Figure 5. The test oils are listed in Table 3.

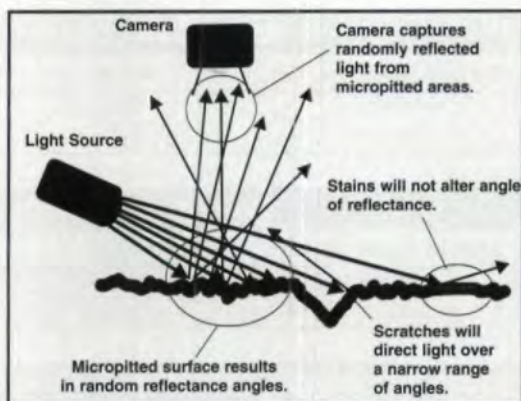
Fig. 6—Schematic showing the light-scattering characteristics from various surface features of the gear tooth under inspection.

The machine vision system is based on light scattering by rough surfaces, as shown in Figure 6. Unworn areas appear dark to the camera because most of the incident light is reflected away from the camera due to the low angle of incidence of the inspection lights. Any micropitted areas on a gear tooth scatter light, in all directions due to the irregular roughness of the surface. Some of the scattered light is captured by the camera, causing the area to appear white. In the absence of other surface features that may scatter light, this approach gives an accurate assessment of the surface affected by micropitting. It thus provides an automated inspection system for following the progression of micropitting while avoiding the need for removing the gears from their shafts.

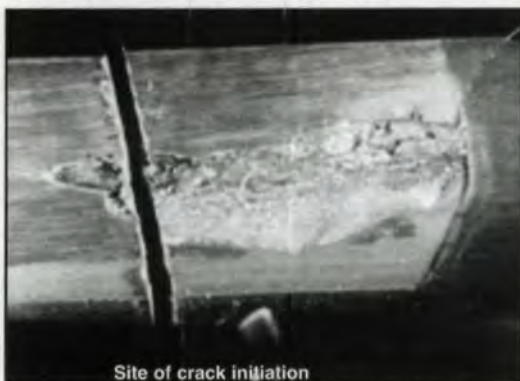
Fig. 7—Pitted gear tooth from the helical gear tests on Oil A. Note that the pit appears to have started from within the micropitted area.

The gear and pinion were analyzed to identify the type of damage and the cause of pitting. It was determined that the initiation of the failure was due to rolling contact fatigue, not adhesive wear. There was also evidence of movement and/or alignment problems with the gears. The photograph in Figure 7 shows a fan-shaped area starting in the micropitted area and terminating with macropits at the pitch line. This result appears to support field observations that have linked the onset of macropitting to areas that have previously been damaged by micropitting.

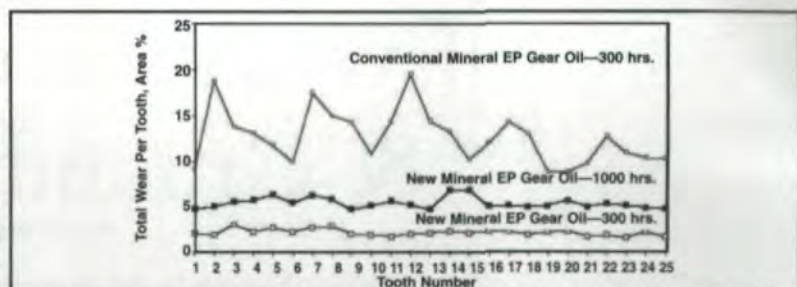
Fig. 8—Micropitted area measured on individual pinion teeth for different lubricants and test times. Note the repeated pattern observed for the conventional EP gear oil corresponds to gear contacts associated with the non-hunting 25/55 gear ratio.

The second test was conducted using Oil B, for which a good rating in the FVA micropitting gear test had been obtained. This oil ran for the entire 1000 hours and had a much lower pinion micropitting rate compared to the previous test. Data for these two tests are graphically compared in Figure 8. Note the repeated pattern in the wear results, which exactly match the non-hunting tooth engagement pattern for the 25/55 pinion/gear tooth configuration. The nominal surface finishes recorded before and after the test are found in Table 4.

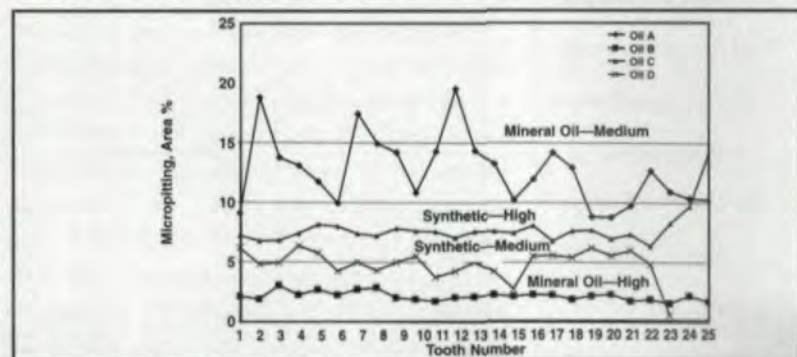
Fig. 9—Micropitted area at 300 hours for oils exhibiting different FVA gear test micropitting performance.

Figure 9 compares the results at 300 hours for the first set of test oils. The mineral oils are rated in the same order as the rating in the FVA test and the synthetic oils are not. These differences may well be related to manufacturing and surface finishing variations between the test gears.
