# REHABILITATION DUE TO UNDERMINING IN VILLALOBOS

VILLA LOBOS - VILLANUEVA - Guatemala

## TYPE OF PROJECT

Reinforced Soil Walls And  
Slope Reinforcement

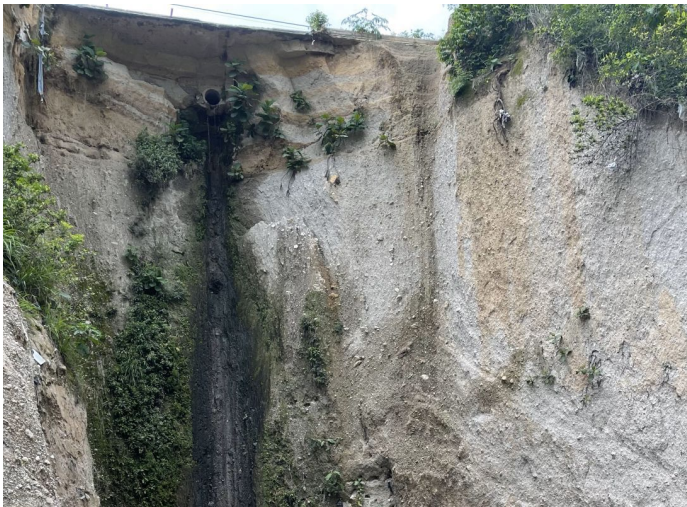
There is a significant erosion issue posing a risk to the stability of the area. Due to the erosion caused by a transverse culvert, the safety factors of the slope are compromised, exacerbating the situation. Additionally, the presence of a river at the base of the slope, flowing

into the southern basin of Guatemala, exacerbates the problem due to flooding and ongoing rains that continue to erode the area. A protective structure with metal mesh DT is required to safeguard the integrity of the infrastructure.

Before the construction

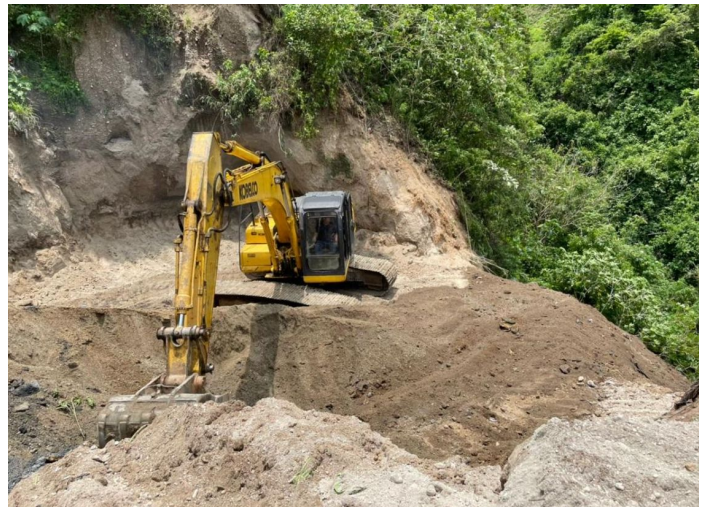
Starting of the works

An environmentally sustainable engineering solution will be implemented. Technologies such as Terramesh System and Macgrid WG will be used to stabilize the slope. Additionally, gabions will be constructed at the base of the slope to protect it from the culvert and river floods, ensuring a long-lasting and environmentally

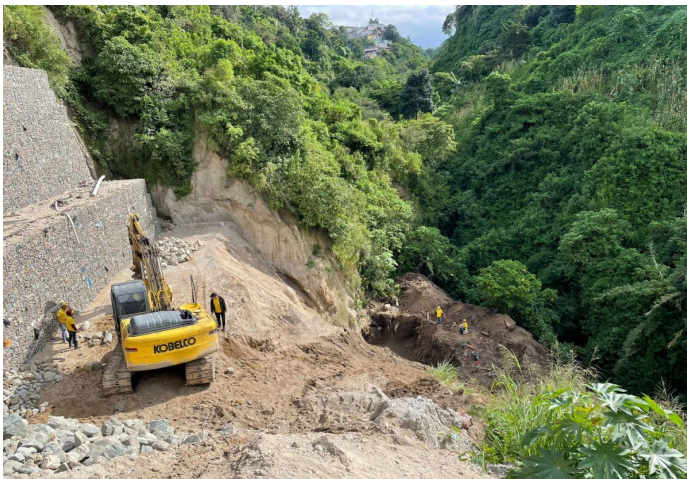
During the construction
