# Coastal Erosion Protection at Downterry Using Gabion Retaining Walls

DOWNDERRY - CORNWALL - United Kingdom

Seawalls And Shoreline Structures

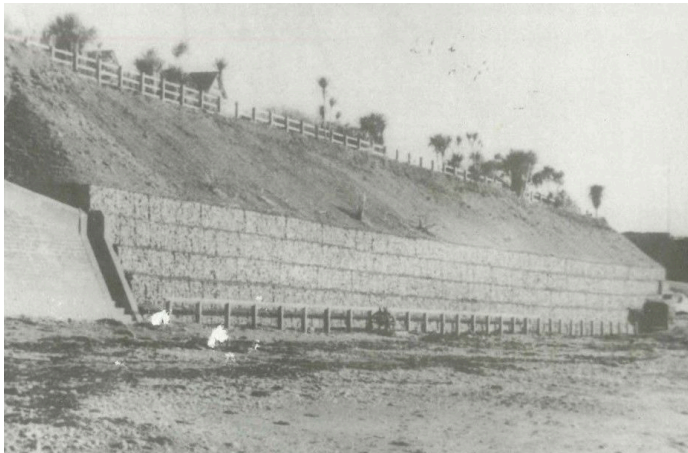
After construction in 1971

To address the coastal erosion and stabilise the cliff, engineers implemented a durable and cost-effective solution using mass gravity gabions. As the cliff was positioned above the normal high tide level, a stepped gabion retaining wall was designed to provide sufficient support without the need for more complex marine structures.

Constructed in 1971, the gabion retaining wall successfully reinforced the cliff base, preventing further erosion and eliminating the immediate risk of landslip. The stepped design enhanced stability while allowing natural drainage, reducing hydrostatic pressure behind the structure.

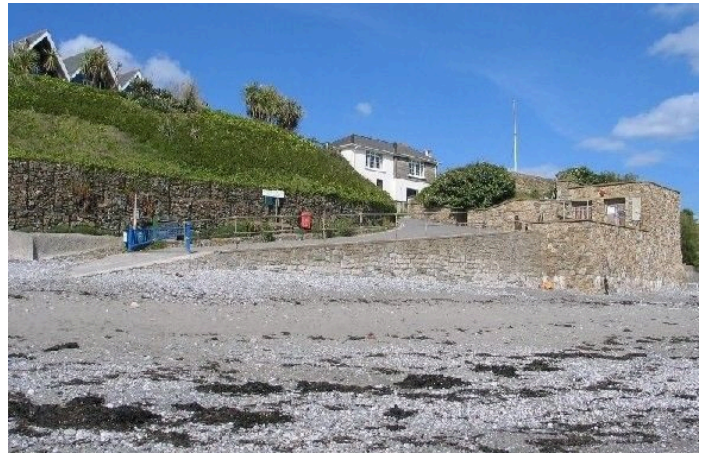
View of the sea defence wall as it now appears

This coastal protection solution not only safeguarded the shoreline but also stabilised the properties above, ensuring the long-term safety of the hotel and surrounding buildings. More than 55 years later, the gabion structure continues to perform exceptionally well. The protective coating and structural integrity of the gabions show no significant signs of deterioration, demonstrating their longevity and resilience in a coastal environment.

In addition to its engineering performance, the gabion wall has naturally integrated into the landscape, supporting vegetation growth and blending seamlessly with the coastal setting. This project highlights the effectiveness of gabion retaining walls as a sustainable and low-maintenance solution for coastal erosion control and cliff stabilisation.

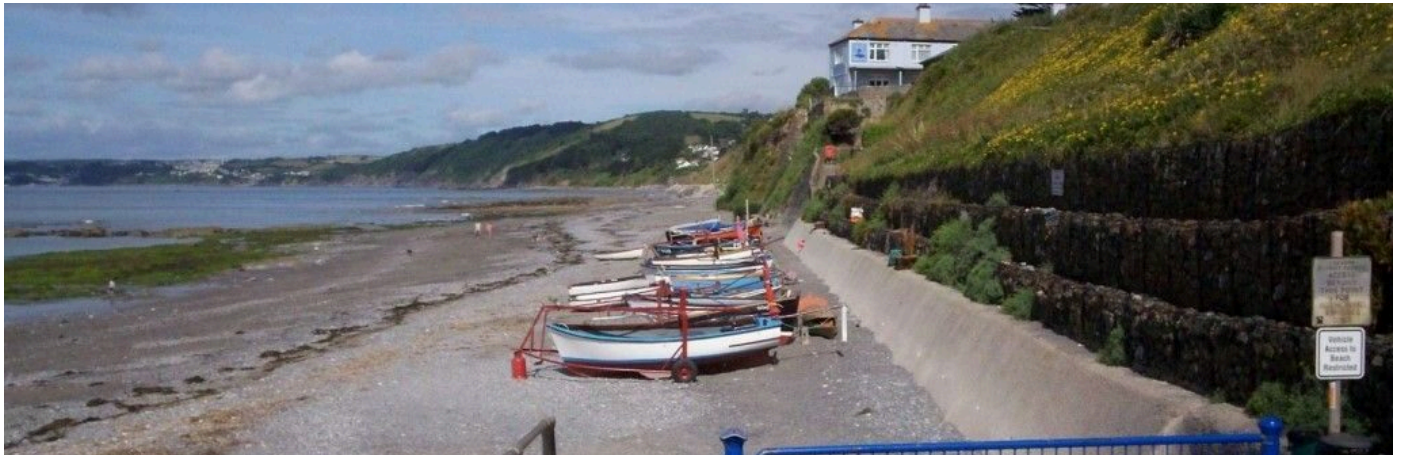
Recent global view of the sea defence wall
