Gear Corrosion During the Manufacturing Process

Omer El-Saeed, Gary Sroka and Gregory Blake

Management Summary

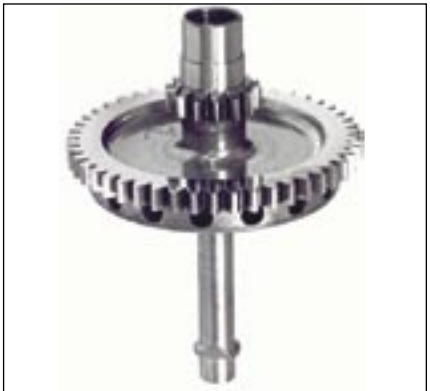
The gearshafts were superfinished using chemically accelerated vibratory finishing (Fig. 10) as described elsewhere (Refs. 4-5).

Figure 10—Superfinished used/scrap carburized AISI 9310 gasifier train gearshaft.

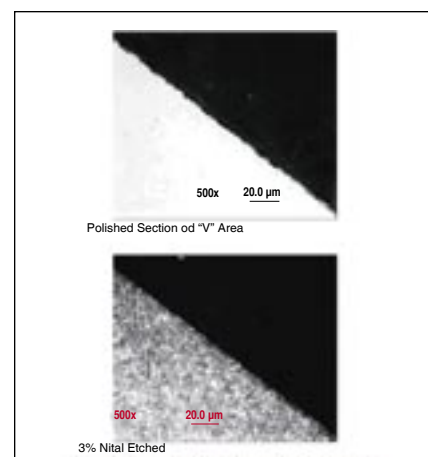
In order to demonstrate that the superfinishing process did not cause IGA, a Falex 9310 V-Block was superfinished under the same conditions as the AISI 9310 gearshaft. The V-Block was sectioned, polished and the V-area was examined. The photomicrographs showed no IGA or pitting (Fig. 17). This definitively confirmed that superfinishing does not induce IGA.

Figure 17—Photomicrograph of the V-Area of the superfinished V-Block at 500X magnification. No pitting or IGA was detected.
