# White Etching Areas on Case-Hardened Gears

Professor Dr. -Ing. Hans Winter,  
Dr. -Ing. Gerhard Knauer  
Technical University of Munich  
John J. Gamel  
Solar Turbines, Inc., San Diego, CA

## Abstract:

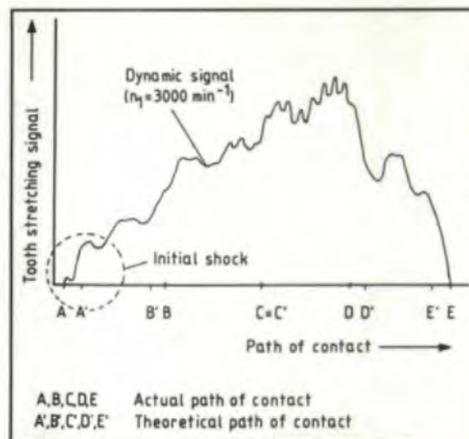
the gear teeth that are in contact are deformed, so that the following gear tooth tip strikes against the flank of the driving pinion in the area of the gear tooth root too early. (See Reference 8.) This leads to an impact shock. Shown in Fig. 5 is the tooth stretching signal of the driving pinion under the conditions described in Table 1, which shows a very steep increase at the beginning of contact which points out a very high shock-type stress at the beginning of contact.

Fig. 5 – Tooth stretching signal in root of the pinion over the length of gear contact. (See Table 1.)

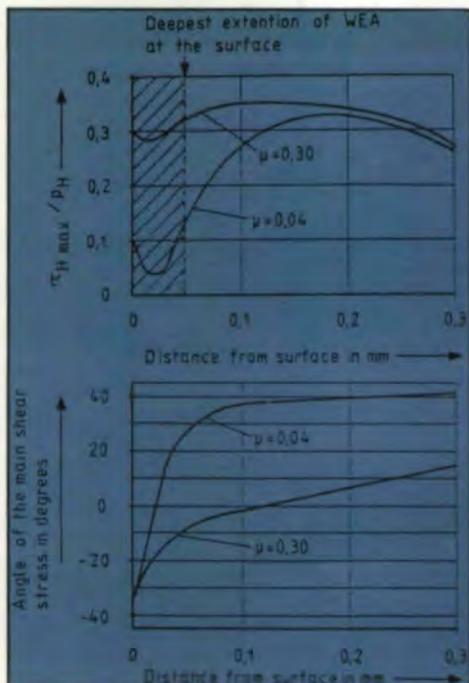
Fig. 8—The path and the direction of the main impact stress for two different friction values.

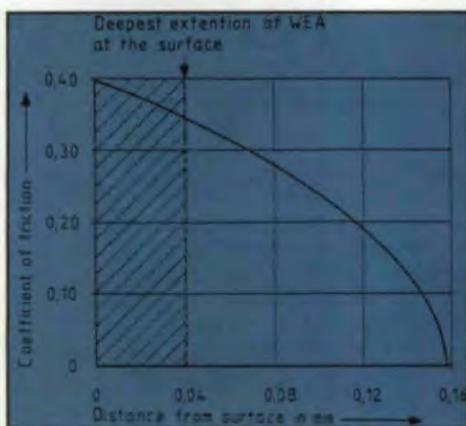
Fig. 10—Location of the maximum impact stress with  $P_H = 1440 \text{ N/mm}^2$   $b_H = 0.20\text{mm}$  in relation to the friction value.

The position of the main shear stress minimum depends on the magnitude of the coefficient of friction. As shown in Fig. 10 from  $\mu = 0.40$  onwards, the maximum main shear stress lies at the surface. As friction stress increases, the point at which the direction of the main shear stress reaches the  $45^\circ$  limit can be found as it travels deeper.
