# YELLOWSTONE HWY 20

CODY - WYOMING - U.S.A.

TYPE OF PROJECT  
**Slope Protection**

PROD. RELATED  
**Rockfall Barriers (450)**

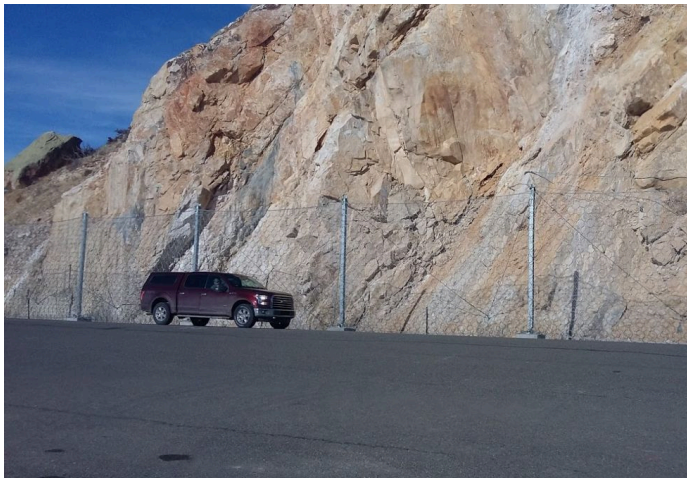
Finished Barrier

Wyoming DOT was faced with a large outcrop of potentially unstable rock beside the very heavily traveled east entrance to Yellowstone National Park. The design showed that the dynamic rockfall protection barrier needed to be 20 feet high and protect over 450 linear feet of the highway. The Maccaferri 2,000 kJ

barrier was chosen and successfully installed after the summer tourist season of 2018. Due to space limitations, the barrier was installed exactly 20 feet away from the white shoulder line of the highway, the tested elongation of the Maccaferri 2,000 kJ barrier is 19.7 feet during a maximum energy level impact event.

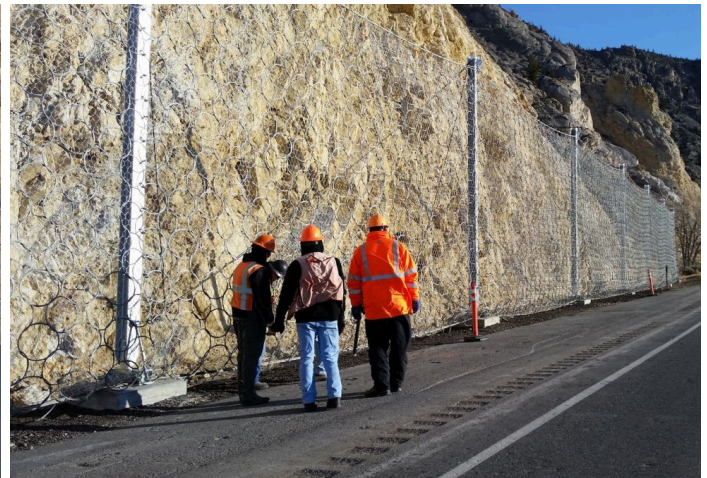
Completed Barrier

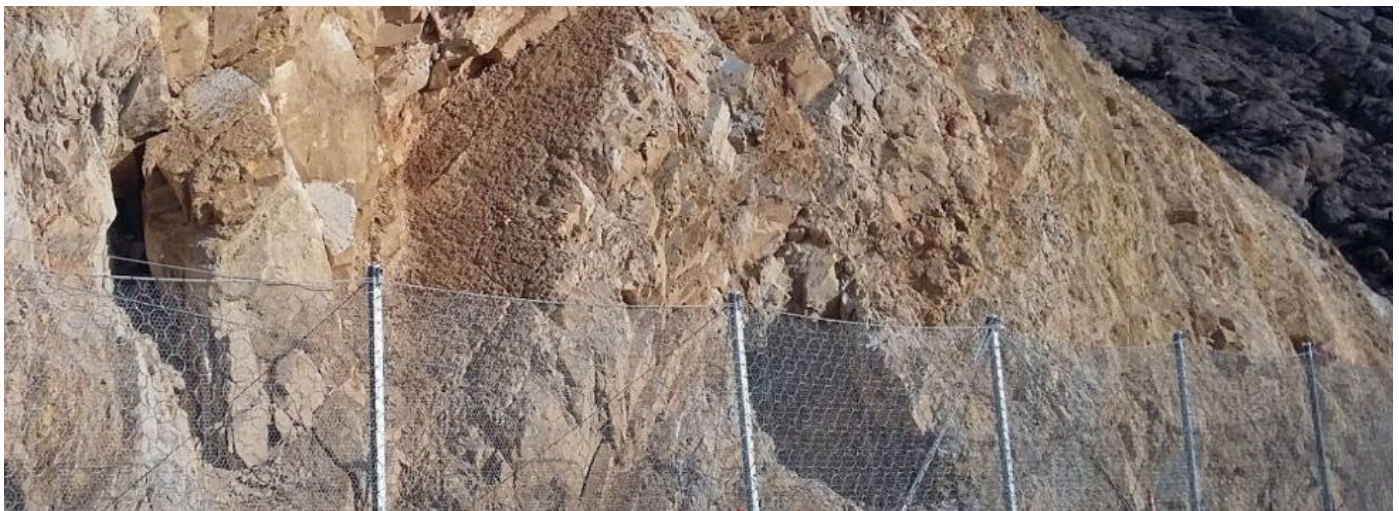
Inspection

The barrier was impacted on May 27, 2019, the opening day of summer travel to Yellowstone National Park. Wyoming DOT was notified of the large rockfall event that impacted the barrier, extending the ringnet to the shoulder of the road. Later Wyoming DOT engineers and geologists estimated the volume of materials that overwhelmed the barrier to be over 900 cubic yards of

rock. Even though this volume of boulders toppled two support posts and ruptured the top support cables of the rockfall barrier, no debris crossed the white shoulder line. The Department of Transportation did not have to close the westbound lane of the highway on the first busy day of the tourism season.
