# Rockfall Protection and Risk Mitigation in Valle d'Aosta

GABY (AO) - VALLE D'AOSTA - Italia

TYPE OF PROJECT  
**Dynamic Rockfall Barriers**

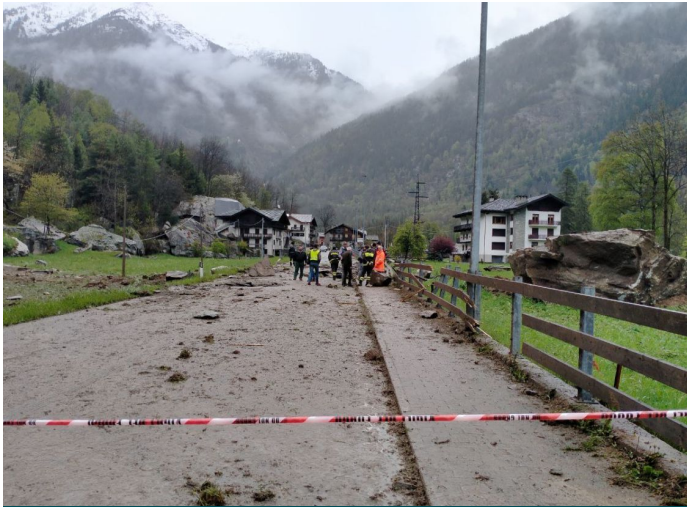
Landslide of May 6, 2022 (Source: Aostanews24)

In the early hours of May 6, 2022, a major landslide struck the municipality of Gaby in Valle d'Aosta, impacting Regional Road 44 (SR 44) near km 16+300, between Serta Desout and Serta Desor.

The event, estimated to have displaced over 500 cubic meters of rock debris (Source: ANSA), caused temporary traffic disruption and highlighted the urgent need for

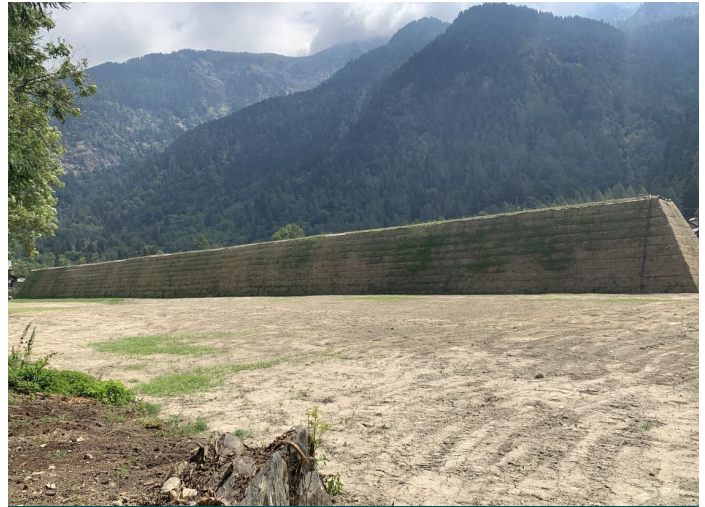
Rockfall barrier detected in Terramesh Verde, installed

Maccaferri provided technical support for the risk mitigation design, which included two key interventions. To protect residential buildings in Serta Desout, RB 9000 rockfall barriers were installed along an 80-meter section. These 7-meter-high barriers are designed to withstand high-energy rock impacts, ensuring reliable protection against large-scale rockfall events similar to the one recorded in May 2022. For SR 44, a dual-face rockfall embankment was constructed alongside the road. Built using Terramesh® Verde

reinforced soil structures, the embankment features reinforcement lengths of 3 and 4 meters, an overall height of just over 7 meters, and extends 150 meters in length. The entire project was completed in just over a month, with all protective structures finalized by mid-July 2022. This rapid deployment was made possible by the efficient installation process of Maccaferri's systems and the strong collaboration between all project stakeholders, ensuring the long-term safety and resilience of the affected area.

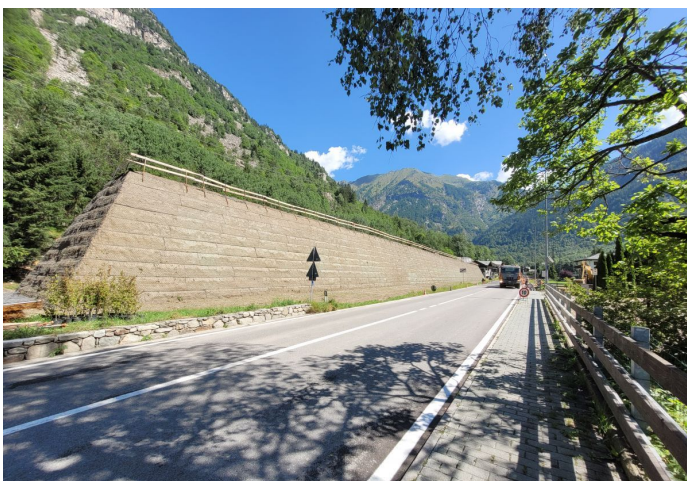
Rockfall barrier detected in Terramesh Verde protecting

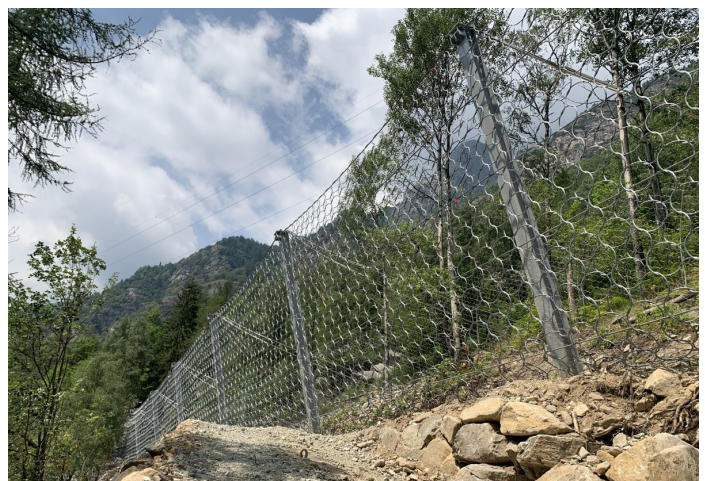
RB 9000 rockfall barriers installed – view from the valley

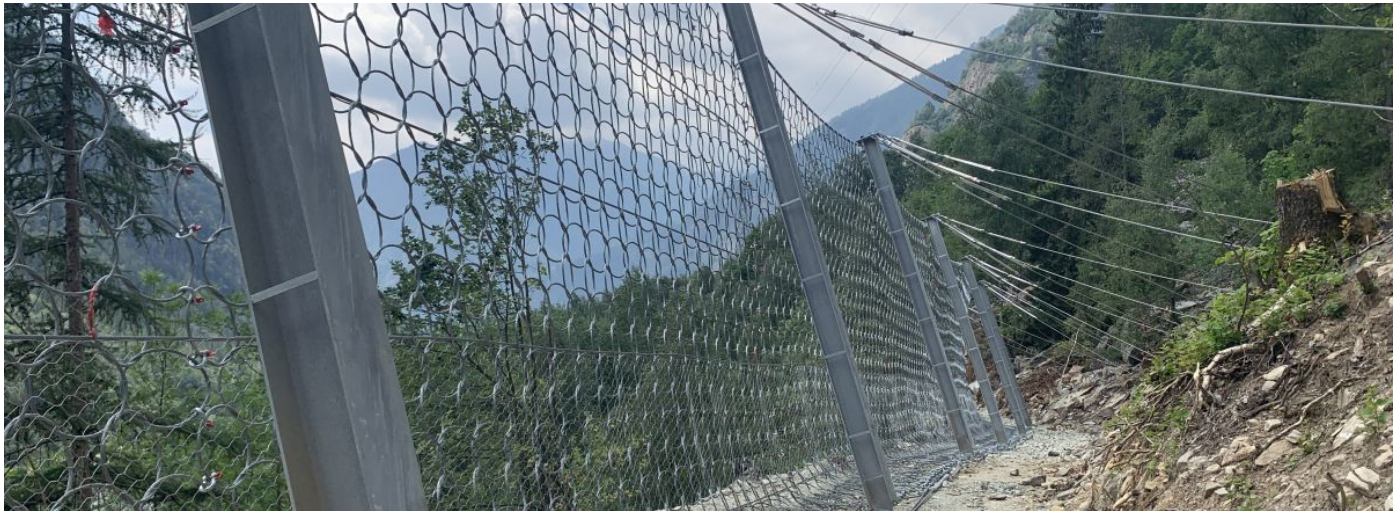
RB 9000 rockfall barriers installed – view from the uphill side
