# HOLCIM PHILIPPINES

AGNO, PANGASINAN - REGION I - Philippines

TYPE OF PROJECT  
**Slope Protection**

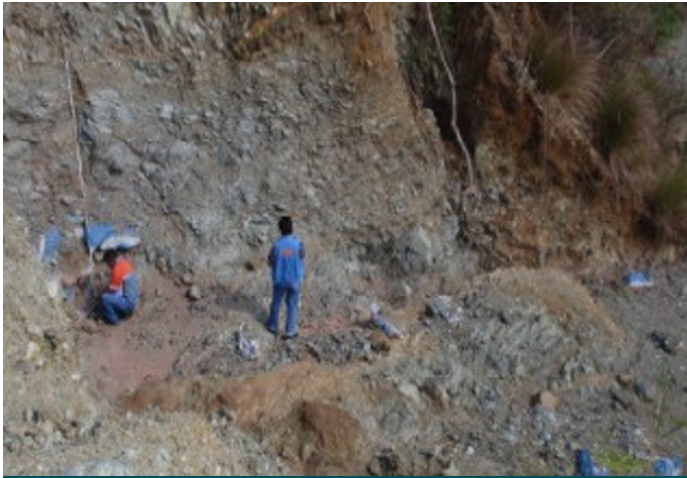
January 2009 - Existing Site Condition

Holcim Philippines, Inc. (HPI) owns a silica quarry operation in the town of Agno, province of Pangasinan, but which was decided to be closed after several years of operation. At site, several stockpiles of silt were left exposed and during rainy season, these wastes were eroded and caused disturbances on a nearby residential area below the quarry site. HPI constructed three temporary silt trap dams to address the problem. However, the materials used in the construction of the dams were just ordinary sand bags thus the structures eventually collapsed. HPI decided to look for a more suitable material to repair the dams.

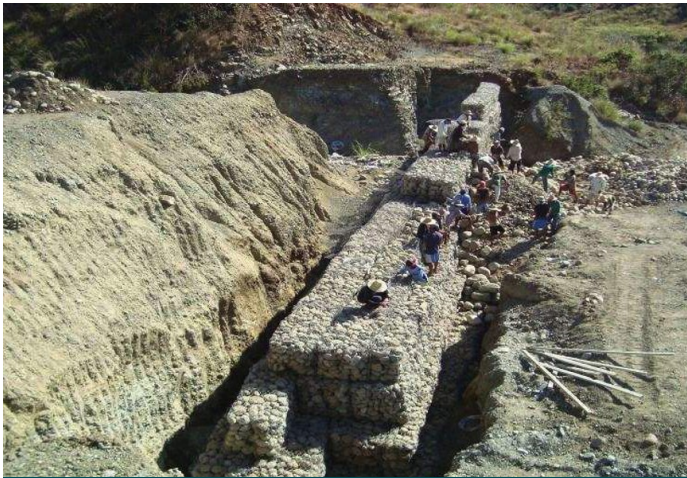
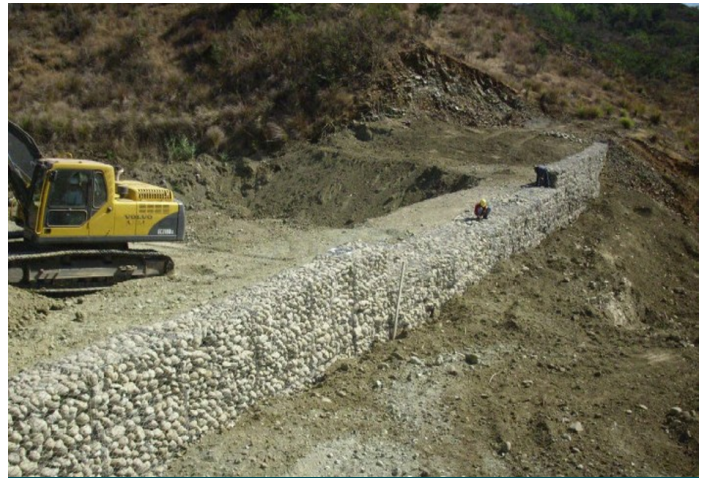
Maccaferri engineers has designed a gabion weir structure using polymeric-coated gabions. The abundance of rock fill materials in the quarry site has highlighted the economical benefits of gabions for the repair of damaged silt trap dams.
