# RELOCATION OF CANKIRI HIGHWAY PROJECT

KASTAMONU - BLACK SEA - Turkey

Basit Örtüleme

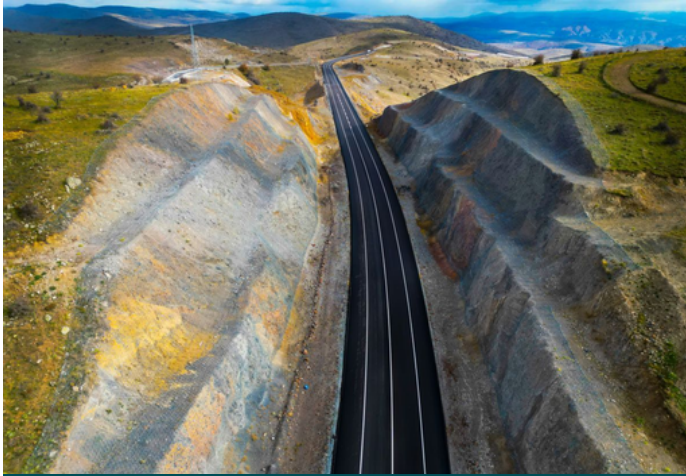
RINGNET INSTALLATION ON SLOPES

In order to resolve the issue, the slopes were analysed and the solution was to cover the slopes with Double Twisted Wire Mesh in order to prevent small debris from falling, as well as a second layer of high capacity ring panels in order to prevent bigger rocks from falling. This solution aimed to stabilize slope's surface in order to prevent surficial rockfalls. Additionally, all slopes

were individually examined from a geotechnical perspective and further measures were implemented based on the specific conditions of each slope locally. Where necessary, surface anchoring was applied alongside the ringnet installations, enhancing the overall safety of the slopes.

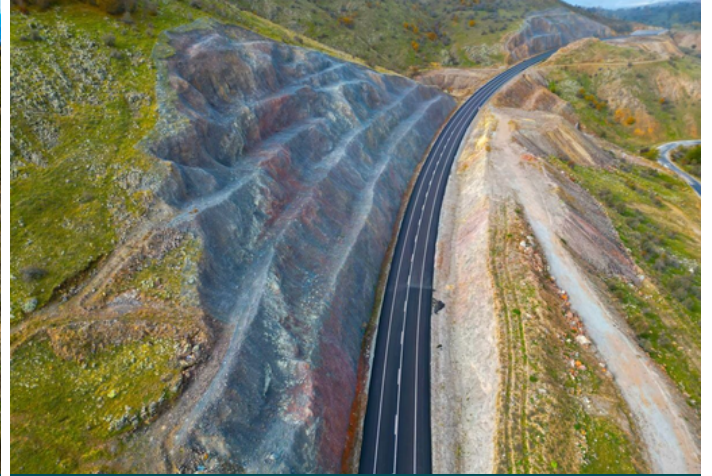
RINGNET INSTALLATION ON SLOPES

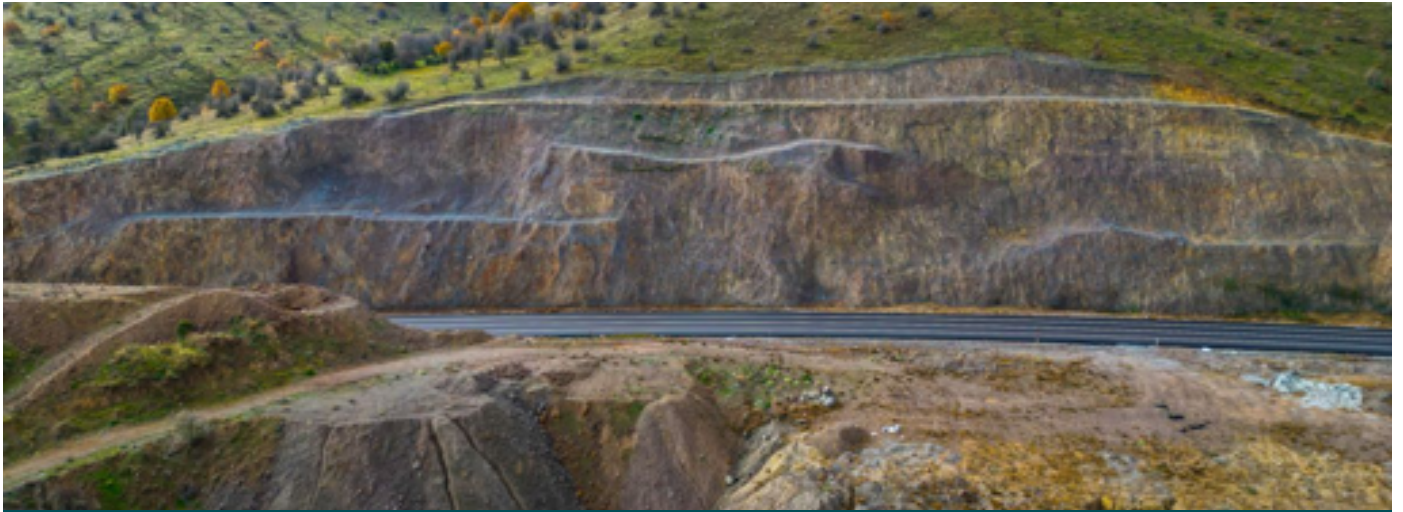
RINGNET INSTALLATION ON SLOPES
