# King County White River Flood Barriers

Pacific, Washington

TIPOLOGIA PROGETTO  
**Barriere Di Sicurezza**

PROD. CORRELATI  
**EBS MAC (500)**

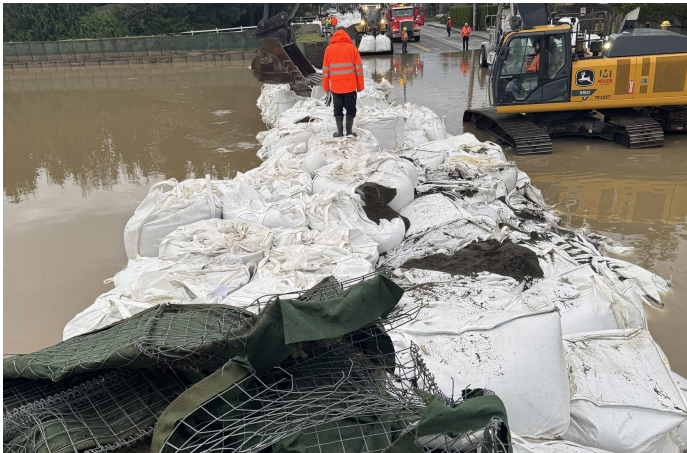
Before: Previous Breached Flood Barrier System

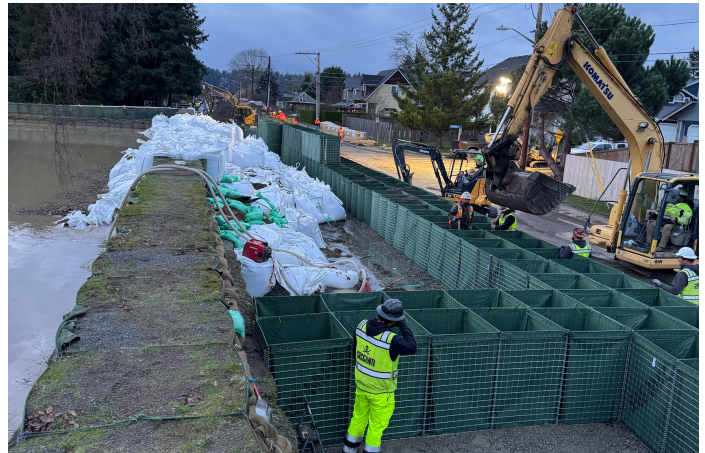
During: Emergency Breach Repair

EBS Mac FE was deployed as part of a comprehensive emergency breach repair and short-to-long-term flood protection system. The system was installed to rapidly restore continuous flood protection across the damaged section while integrating with the existing flood barrier and meeting emergency deployment requirements.

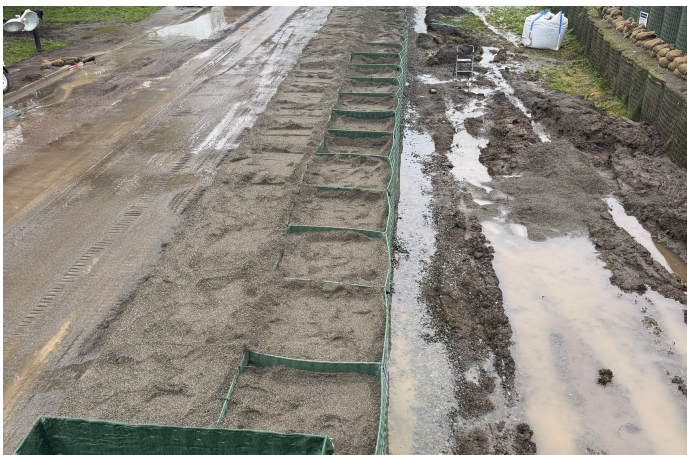
During: Emergency Breach Repair Protecting Pacific Park

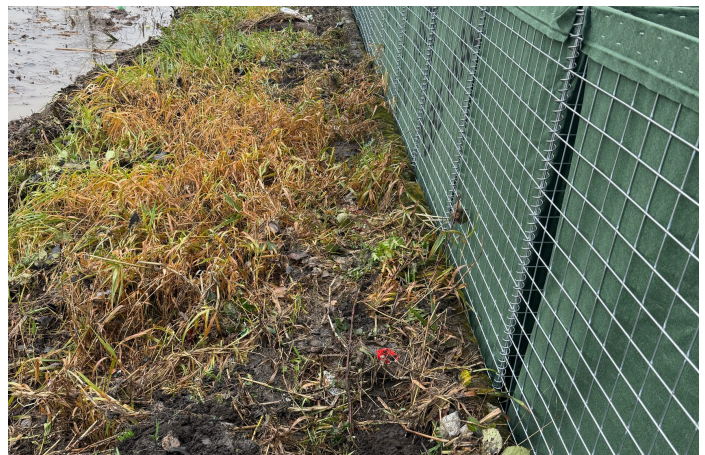
After: White River Flood Protection Barriers
