# Su ehri- ebinkarahisar Road Rockfall Risk Mitigation Project

EAST ANATOLIA REGION -S VAS

PROJE T R   
Y zey G  lendirme Ve  
Destek

M   TERİ  
HIGHWAY AUTHORITY

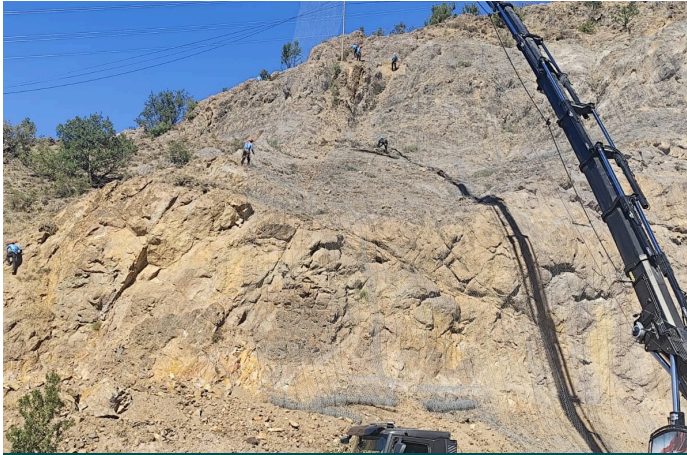
During the construction

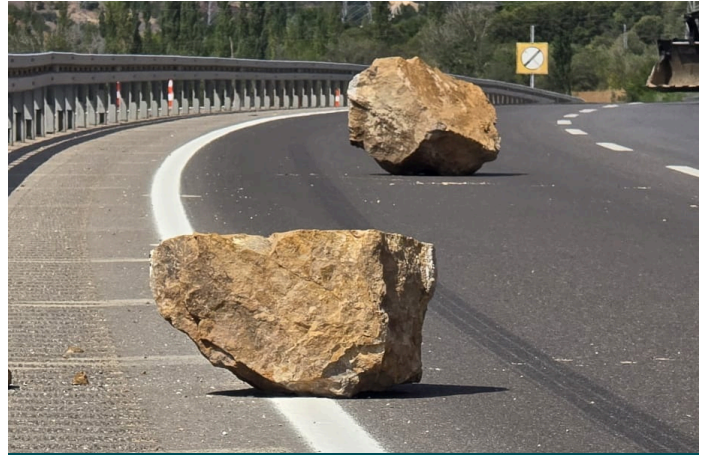
During the construction – controlled scaling of loose rock

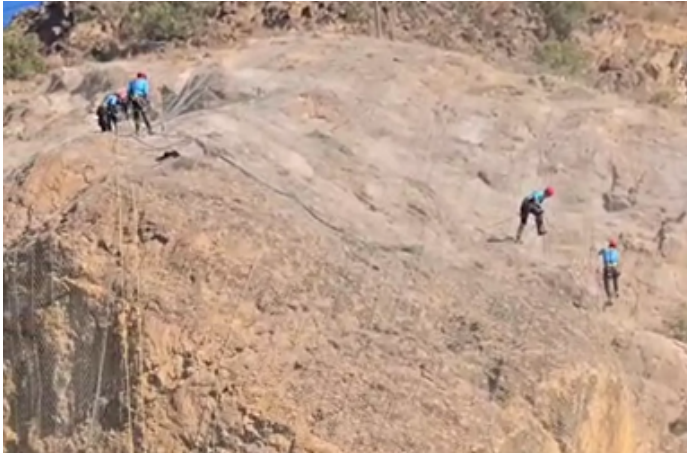
During construction – installation of surface anchors

In addition, a total of **1.050 surface anchors** with specifications **2,0 m** length were installed in a **2.0 × 2.0 m grid pattern**. These anchors were designed to stabilize the rock mass by increasing internal resistance, securing potentially unstable blocks, and improving the interaction between the rock surface and the applied mesh system.

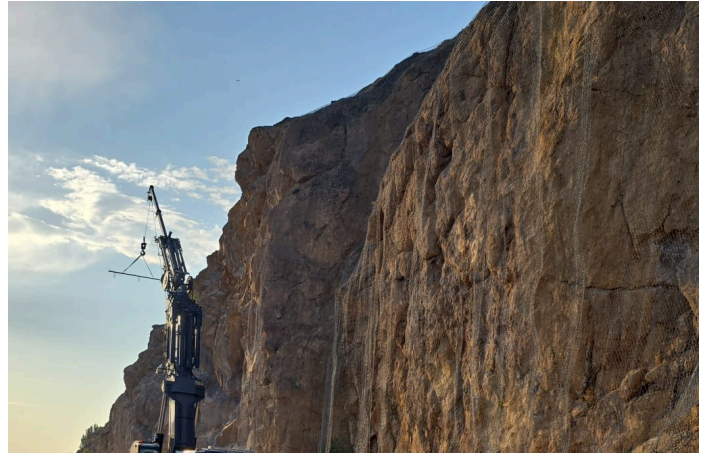
After the construction

Within the scope of the project, a total area of 8.580 m<sup>2</sup> was covered using high-capacity **Steelgrid HR50** systems. This flexible surface support system was applied to control shallow instabilities, prevent the detachment of loose rock fragments, and ensure overall slope integrity.

The combined application of Steelgrid systems and systematic anchoring significantly enhanced the mechanical stability of the slope, reducing the risk of rockfall and surface erosion. These measures also provide resistance against external triggering factors such as weathering, precipitation, and seismic effects.
